Inspections of hydraulic and slope stability structures with UAV-based high definition thermal camera

Keywords: UAV, Thermal-sensing camera, hydraulic structure, crack inspection

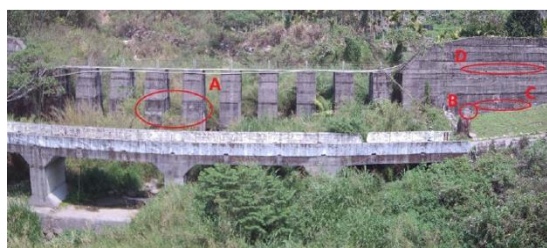
Figure4 : Location distribution of Area A~D

In this study, the hydraulic structures (including bank revetment, comb dam and bed fixing, etc.) in seven areas of the Nantou mountain region were photographed by UAV equipped with a visible light camera and a thermography camera. The result of preliminary comparison in one of these areas is shown utilizing analyzing and verifying the difference and comparability of the imaging result of the hydraulic structure through the two cameras in different times and situations. In this area (Tannan Village, Xinyi Township), there are a lot of suspected cracks found in 4 locations (A~D) for detailed analysis. The distribution locations are shown in Figure 4.

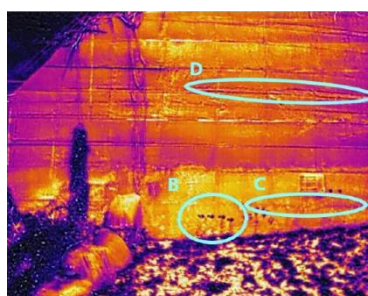
By observing the thermography, A of this area (as shown in Figure 5, the (1) and (2) in the figure show irregular lines, and (3) and (4) on the comb dam column show darker color blocks and line types. After compared the visible light images (such as Figure 6), it is found that there are suspected cracks in (1) and (2), and possible defects of concrete reinforcement as shown in (3) and (4). Observing the thermography cases of B~D in this area (shown in Figure 7), there are several dark circles at B, and irregular lines at C and D. After compared the visible light images (Figure 8),

Figure7: Infrared thermography at dam wing in area B

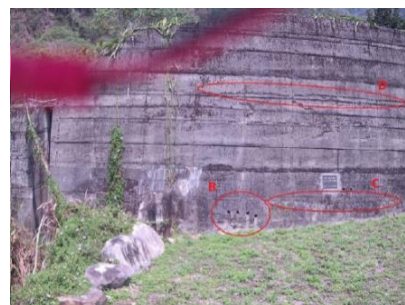
Figure 8: Visible light image at dam wing in area B~D

it is found that B is drainage holes, whereas C and D are suspected cracks.

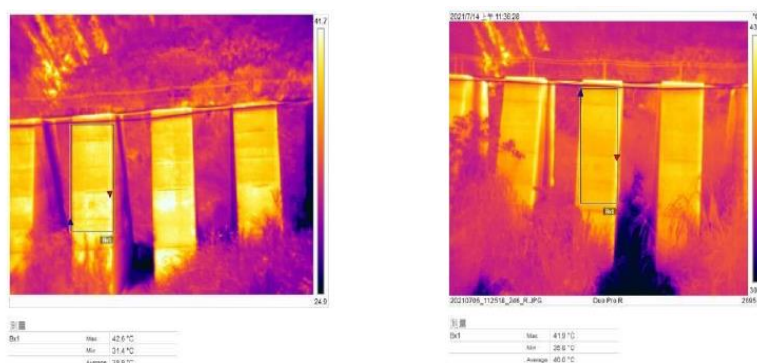
The research conducted the second flight shooting and comparison at the same location on July 6, 2021. At this time, the shooting method mainly focused on the area spot shooting. The part of the suspected structural problems obtained from the initial flight shooting is carefully recorded, and the following factors were discussed in the impact of the image presentation. After the flight shooting was completed, using the software FLIR TOOL to make an analysis (as shown in Figure 9) and compare the maximum and minimum temperature differences in different weather conditions at the same location. The result shows that the difference between high and low temperatures was 11.2°C in a sunny environment; during the second flight, the difference between high and low temperatures was 5.3°C in cloudy weather.

Figure 9: Use FLIR TOOL to analyze the thigh-low emperature difference in Area A

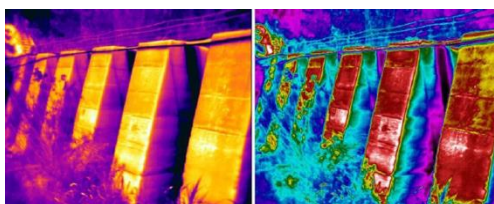
The difference in thermography images taken between the two flights: in the mid-term flight verification (on July 6), the suspected cracks in area 4A and the reinforced concrete condition were compared with the one taken in the initial flight (on February 22). It became less apparent in the thermography images, as shown in Figure 10 and Figure 11.

Figure10: Thermography taken in February

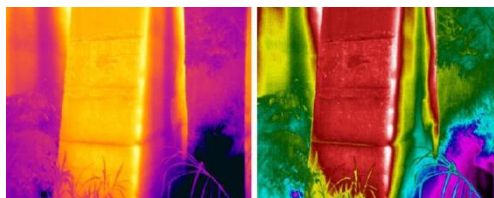
Figure11: Thermography taken in July

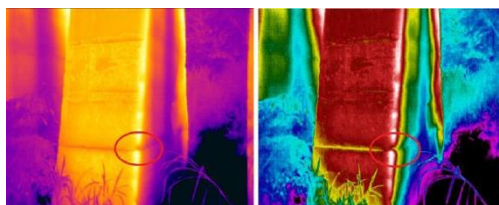
Other discoveries in the study: when manually reviewing the photos, the research found that the corners of one of the dam columns on the comb dam had uneven temperatures (as shown in Figure 12); the difference between high and

Figure12: The temperatures at the corner of dam column taken in July is uneven (iron rendering in the left picture, rainbow HC rendering in the right picture)

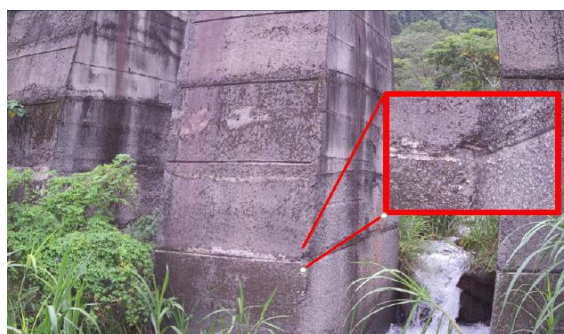
low temperatures was about 4°C. Therefore, the visible light image was used for comparison (as shown in Figure 13). The research found that the point of low temperature was the concrete damage with the exposed steel bars. It is assumed that heat at the exposed steel bars dissipates faster than in concrete in cloudy weather, so it appears the dark color in the thermography, which is in contrast to the lighter color of higher temperature nearby.

Figure13: Visible light image of dam column and locally enlarged picture taken in July
