DAMAGE DETECTION OF THE MAY 6, 2012 TORNADO IN TSUKUBA, JAPAN USING AERIAL THERMAL INFRARED IMAGES

KEY WORDS: Tornado, Aerial Thermal Infrared Image, Temperature Distribution, Damage Detection, GIS

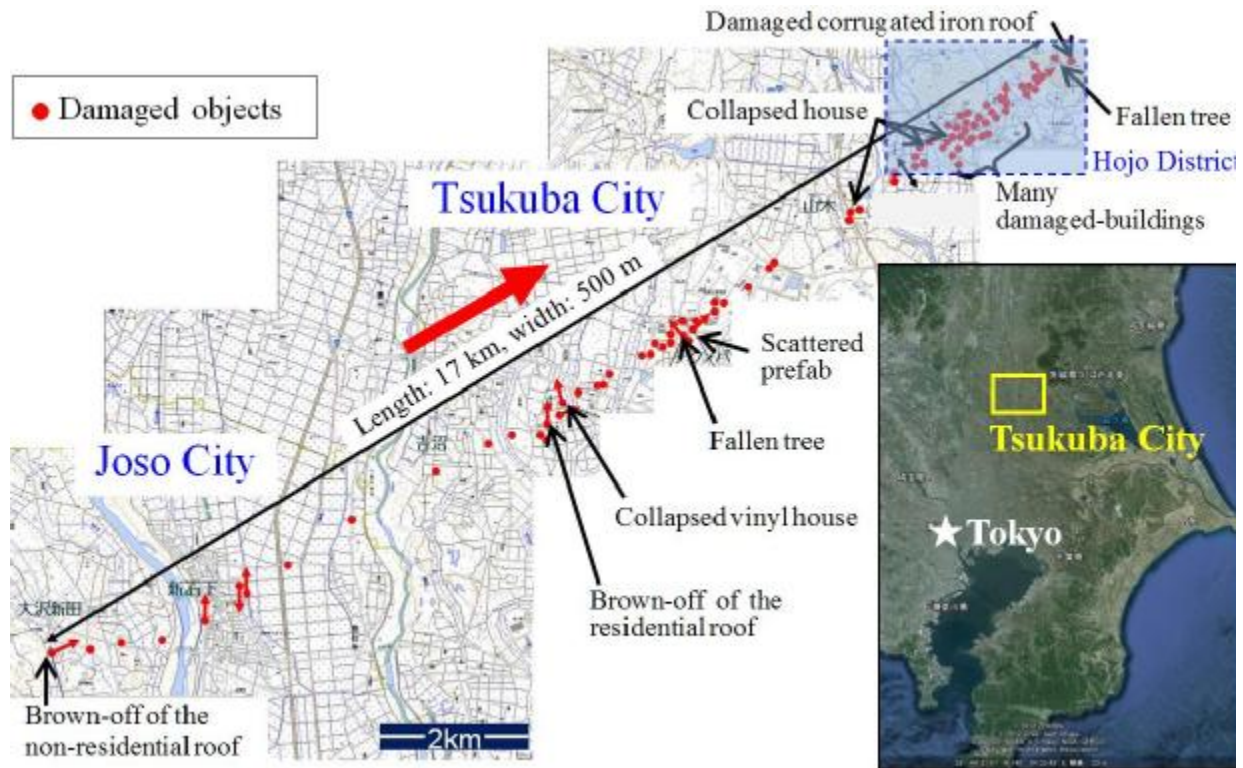
A strong tornado was generated in Joso City, Ibaraki Prefecture on May 6, 2012 at 12:35. It caused significant damages along its path with 17 km in length and 500 m in width, until its end at Tsukuba City (Figure 1). The moving speed of the tornado was about 60 km/h (passing 17 km in 18 min) based on the analysis of meteorological Radar by Japan Meteorological Agency (JMA, 2012). JMA judged the Fujita scale of the tornado as F2 (the average wind speed

Figure 1 Detail map of the tornado's path and resultant damages, modified from JMA (2012).

of 50-69 m/s in 7 s) based on their field survey after it passed by. However, it was changed to F3 (the average wind speed of 70-92 m/s in 5 s) in June 8 because the resultant damages were found to be so severe; for example, one wood-frame house was overturned upside-down with its concrete base.

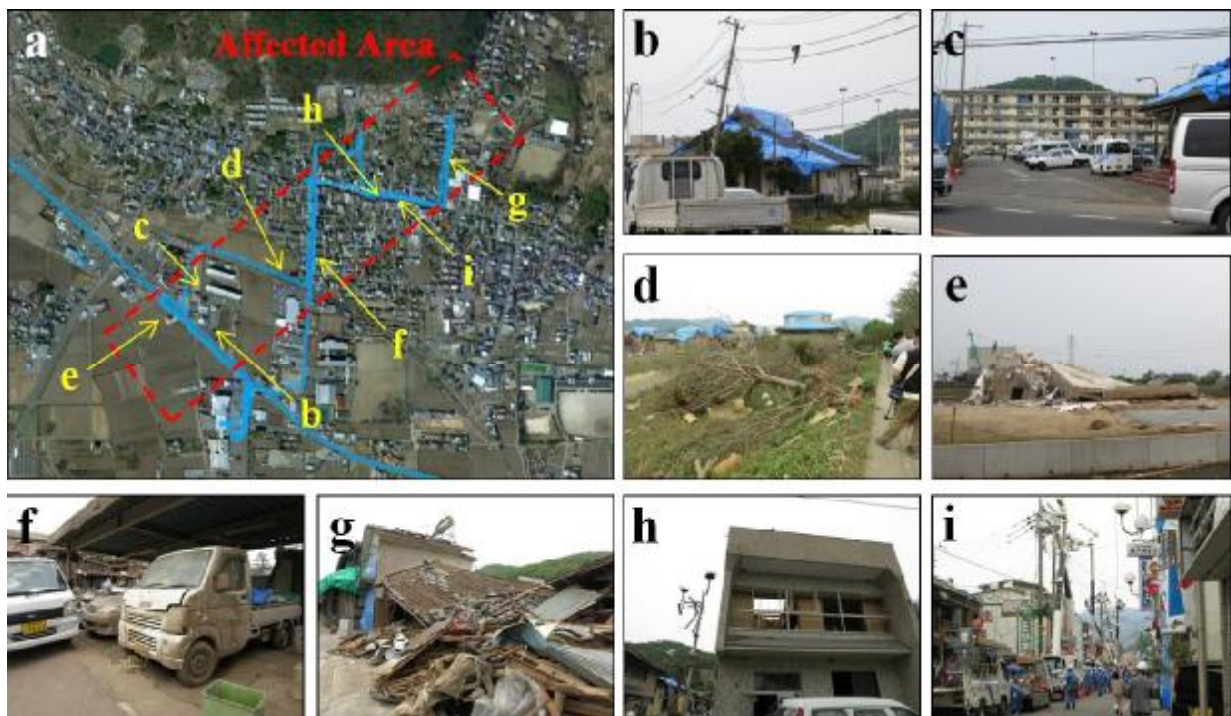
Typical damage scenes are shown in Figures 3b to 3i. Many buildings were collapsed or brown off their roofs, and these were covered by blue sheet (Figure 3b, 2h). Trees were uprooted, and a wooden house was overturned upside-down with its concrete base (Figure 3e). The Fujita scale was changed to F3 by this damage. Many objects were covered with mud because the tornado hit the area with rain (Figure 3f). This might affect the surface temperature. Debris and mud on roads were mostly cleaned up already at the time of our field survey although some still remained. Recovery efforts were very fast because the tornado damage was localized. Restoration of electric poles and cables were going on with many trucks and workers (Figure 3i).

Figure 3 (a) The area of field survey in Hojo district of Tsukuba City and photo shooting locations, (b) Blue-sheet on the roof, (c) Damage on the side wall of the apartment building, (d) Fallen trees along the street, (e) Overturned wooden house with its concrete base, (f) Cars stained with tornado's mud water, (g) Buildings that reduced to debris, (h) Brown-off of the roof (the sky is seen from the window), (i) Restoration work of electric poles and cables.

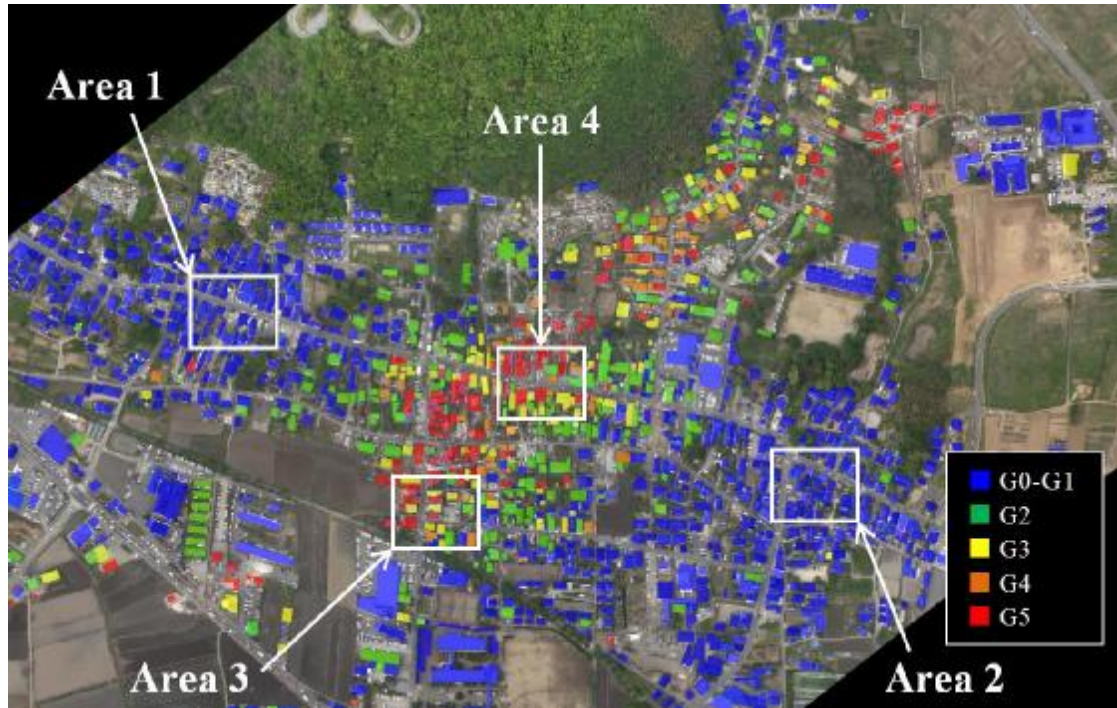
Figure 4 shows the result of our visual damage inspection from the daytime aerial visible image based on the criteria in Table 1. It is seen that the grades G3-G5 buildings were located along the path of the tornado. In this step, some buildings were judged as no damage although some damages on their side surfaces, like the apartment building in Figure 3c, because the damage was judged only from the roof condition. This might be the reason of the difference between our inspection result with the damage assessment result by Tsukuba City, as shown in Table 2. In this study, however, our inspection result was used as the reference data for the aerial TIR images since the both data were acquired from the same vertical view angle, where only the damage condition or the temperature of the roof was seen.

Figure 4 Damage classification result by our visual inspection of the daytime aerial visible image

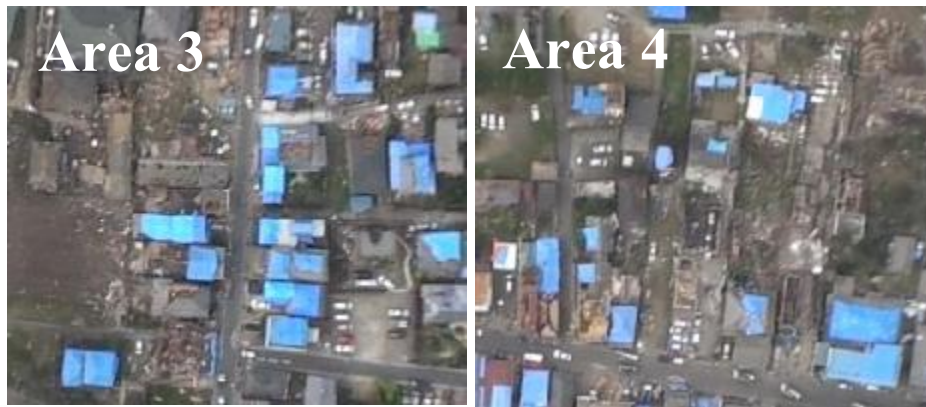
Figure 8 Target areas of heavy-damage in Figure 4.

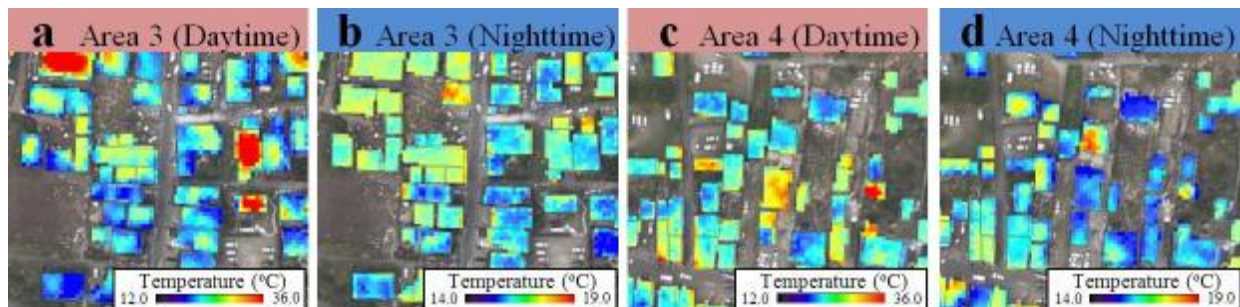
Next the characteristics of the TIR images at heavily-damaged areas were discussed. Figure 8 show the locations of two target heavily-damaged areas in Figure 4. Figure 9 shows the surface temperature within the building footprints from the daytime and nighttime TIR images, superimposed on the visible image. From the daytime roof temperature distributions in Figures 9a and 9c, damaged roofs mostly show low temperature because they were covered by blue sheet or reduced to debris. The nighttime roof temperature distributions in Figure 9b and 9d also exhibit low values. The temperature distributions for heavily-damaged buildings are seen to be somewhat different from those of non-damaged ones both at daytime and nighttime, but this observation is highly affected by the material, color and orientation of the roof, shadow and surrounding conditions.

Figure 9 Temperature within building footprints for heavy-damage areas, a, c: Daytime, b, d: Nighttime.

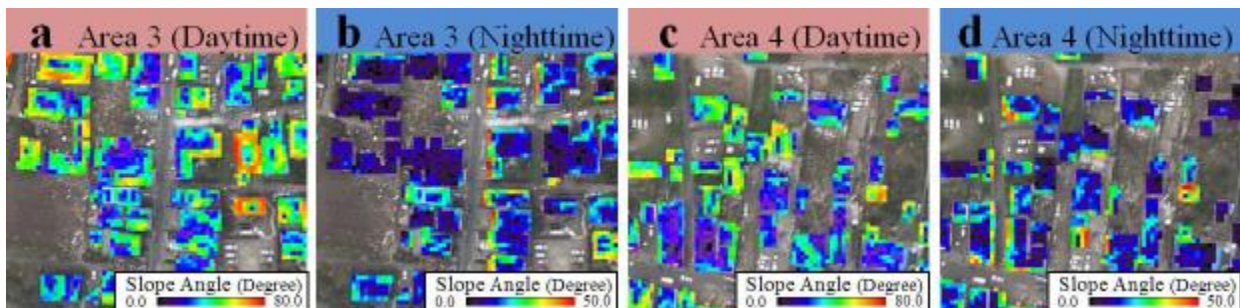
Figure 10 shows the slope angle of the surface temperature within the footprints. In the daytime slope angles in Figures 10a and 10c, many buildings show small values as in purple to blue colors. It is also observed that the pixels with large angles are few probably because buildings were reduced debris and it spread in and outside of the original building footprints. Many materials were mixed up by building collapse and thus many objects became a mixed-pixel (mixel) condition for the low resolution TIR images (1.54m). This characteristic is remarkable especially for the upper left building group in Figure 10b. Most footprint areas show small changes as in dark blue color. It can be seen in the visible image of Area 3 that the spread debris in the area became the similar condition as soil. This kind of debris spread was also observed in our field survey, and hence there is possibility to use this more uniform temperature distribution with the surroundings in early damage detection from TIR images.

Figure 10 Slope angle of the temperature within building footprints in Figure 9, a, c: Daytime, b, d: Nighttime.

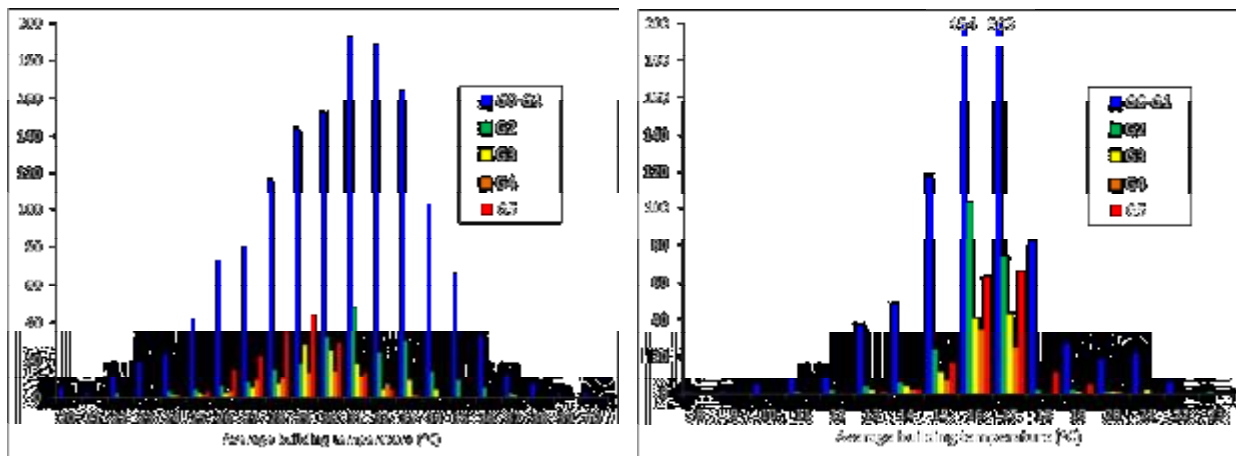
From the daytime histogram in Figure 11a, the average roof temperatures for non-damaged buildings are seen to be widely distributed in the range from 20 to 40 °C. On the contrary, those for damaged buildings are displayed in a narrower range from 24 to 35 °C and the range gets small as the damage level gets higher. For collapsed buildings (G5), the average temperature becomes in the range from 25 to 33 °C. This is because that the roofs were lost and the footprint areas were covered by the mixture of various materials like debris and mud. If we can use a much higher-resolution TIR image, a wider temperature distribution can be seen in more detail. But at this time, the resolution of our TIR images are 1.54 m, and thus most debris became in a mixel condition and the temperature distributions became flat. The histogram for damaged buildings at daytime tends to be in a narrow range and the average values were decreased for 2 or 3 °C.

From the nighttime histogram in Figure 11b, the average temperatures for most buildings are seen in narrower ranges, around 17 °C, compared with the daytime histograms, as typically observed for collapsed buildings (G5). The histograms for damaged buildings at nighttime also tend to be in narrower ranges, the same as the daytime case. This kind of temperature characteristics in aerial TIR images may be used in early damage detection in the future although more examples for various conditions should be tested.

Figure 11 Histogram of average temperature within footprint for each damage level, a: Daytime, b: Nighttime.
