INSPECTION OF PAVEMENT SURFACES BY THERMOGRAPHY

Andrew KUTTIN-MENSAH*¹, Mitsuharu TOKUNAGA², Ernest APRAKU¹, Latif SUBOI¹

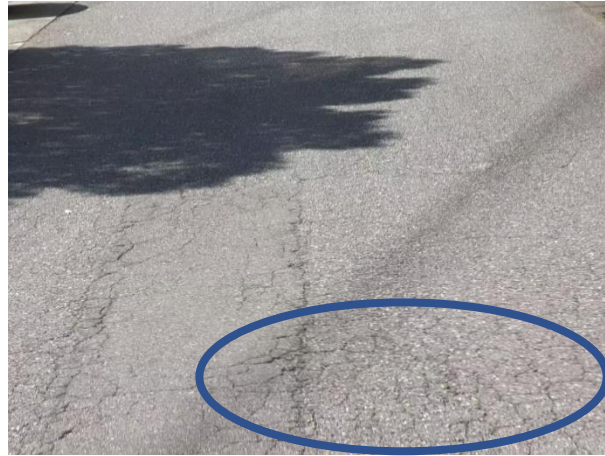
- Alligator Cracks
Alligator cracks refer to a series of interconnected cracks that form on a road surface.

Figure 1 Alligator Cracks

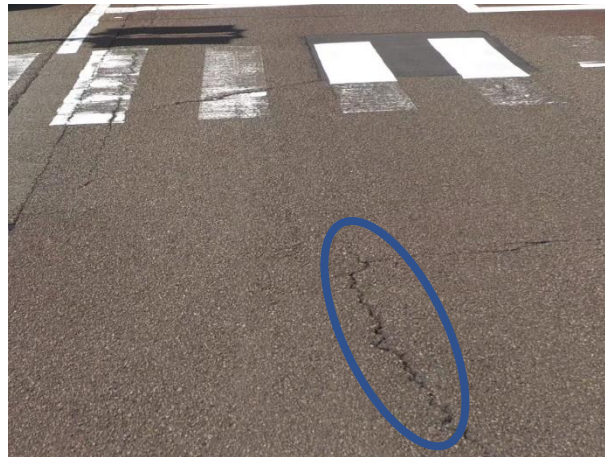
Longitudinal cracks are cracks that form on road surfaces and are oriented in direction of traffic flow.

Figure 2 Longitudinal Cracks

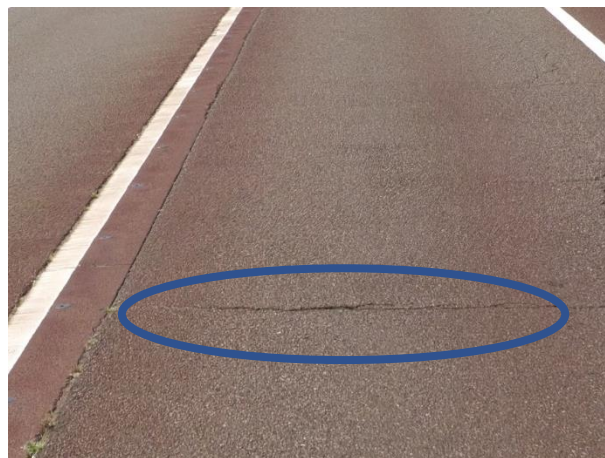
This type of defect are cracks that occur in a direction perpendicular to that of traffic flow on a carriageway.

Figure 3 Transverse Cracks

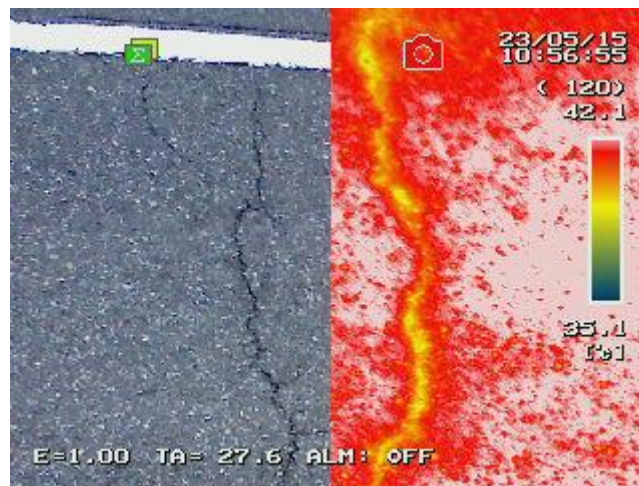
Figure 4 Composite image of crack defect

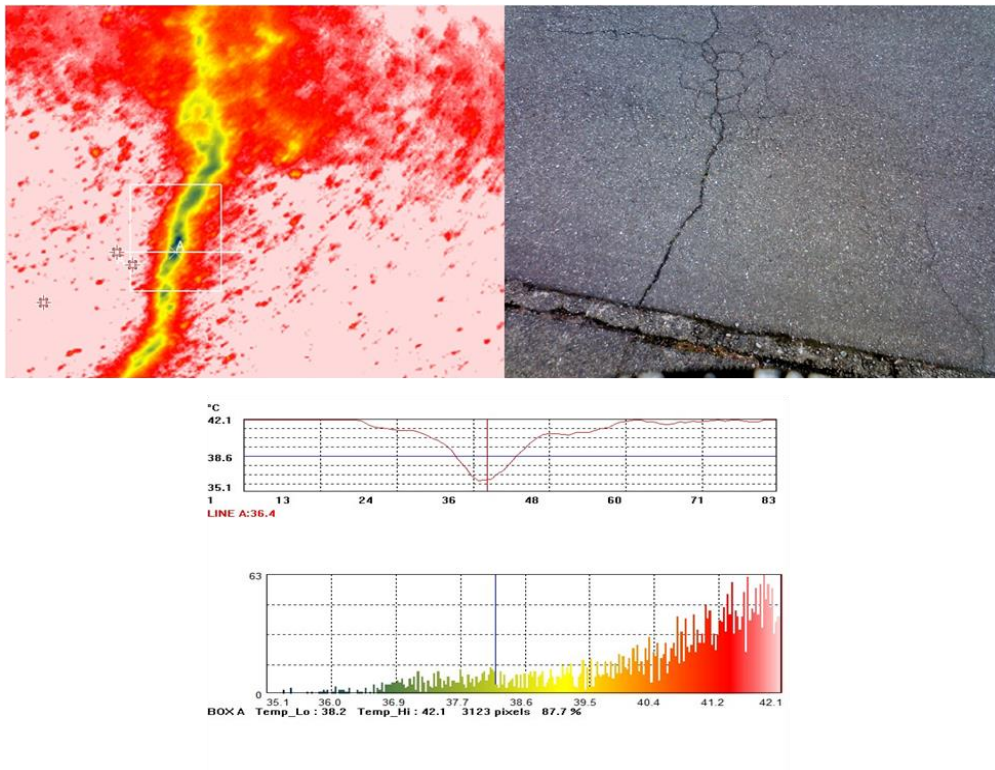
Still photos were taken on a candidate road in the Kanazawa Institute of Technology that had defects present. Analysis of the still photos in InfRec Analyser NS9500 showed that there was a variation in temperature between the sound pavement and the point at which cracks were identified. This is shown by the line graph in Figure 7. A histogram produced from analysis of the image also shows that the lower temperatures were recorded within the crack. The results showing the temperature variations at the point of the defect are in agreement with the work done by (Solla, et al., 2014).

Figure 7 Temperature Distribution in Defect Zones

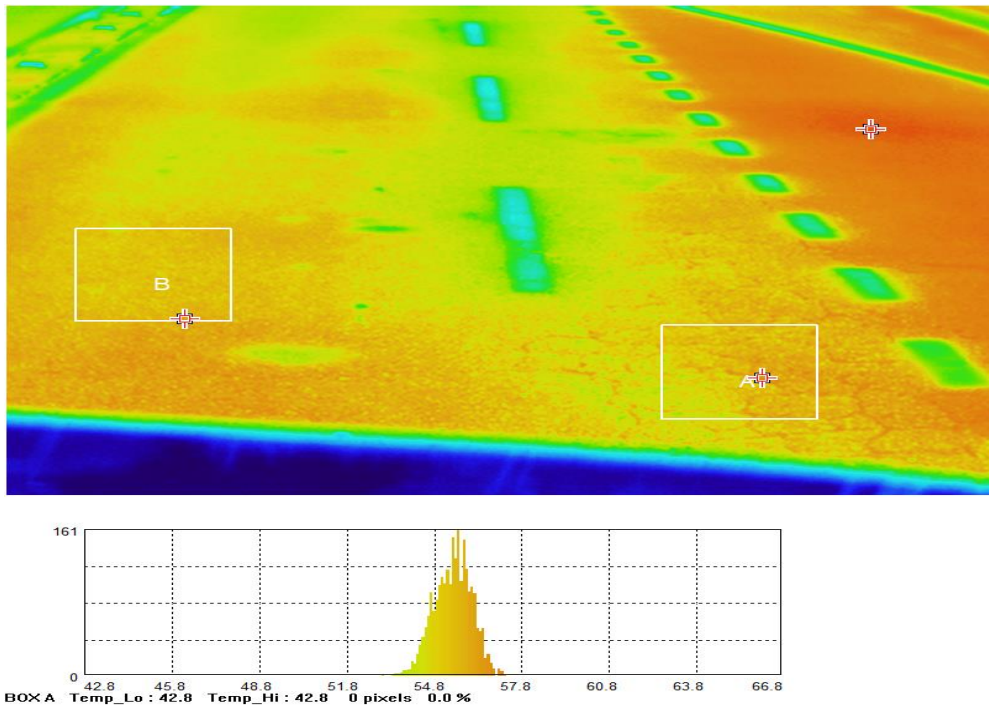
The field survey was undertaken on a road leading from Takahashimachi to Arimatsu on a cloudy day with ambient temperature of 32°C. In stationary state sufficient information was captured from the extracted imagery (Figure 8). While in motion however the quality of the image was insufficient to gather enough information on the state of the pavement surface (Figure 9).

Figure 8 Alligator Cracks in extracted while stationary Thermal Photo

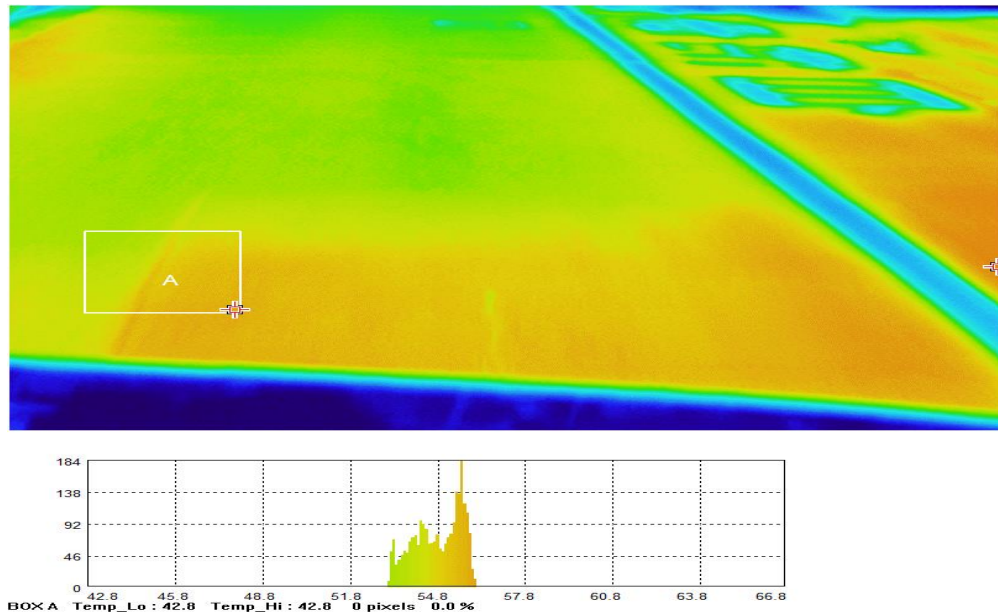
Figure 9 Patch section in extracted while in motion Thermal Photo

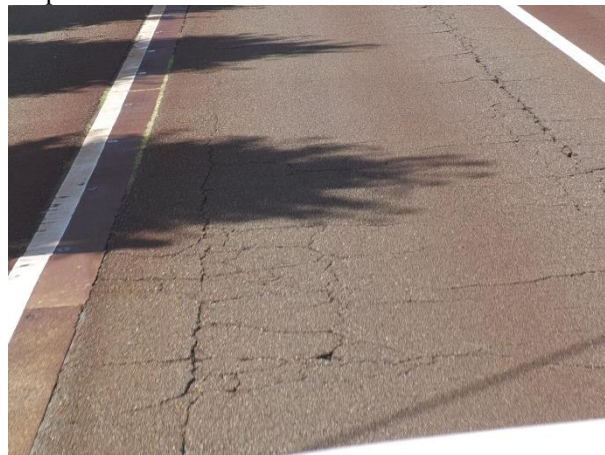
The normal video taken was also processed and divided into frames. These frames were then examined and sections of the route where crack defects were present were identified.

Figure 10 Extracted image from normal video
