ESTIMATION OF TSUNAMI-INUNDATED AREAS USING SATELLITE IMAGES AND NUMERICAL MODEL IN ASAHI CITY, CHIBA PREFECTURE, AFTER THE 2011 OFF THE PACIFIC COAST OF TOHOKU EARTHQUAKE

Ken Kitamura ^a, Yoshihisa Maruyama ^b and Fumio Yamazaki ^c

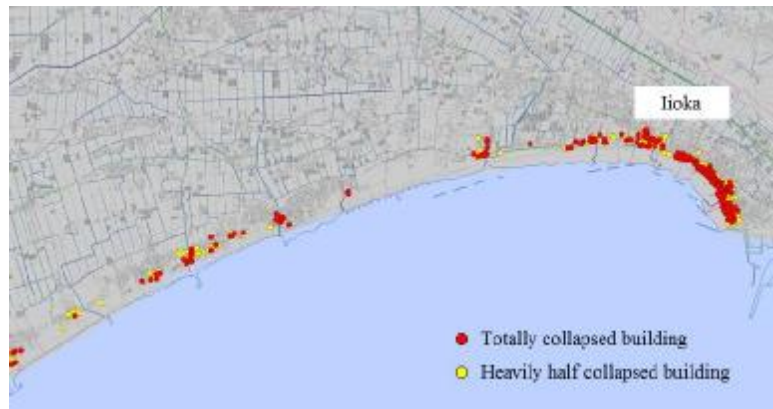
Figure 1 shows the distribution of damaged buildings by the tsunami in Asahi City. In the figure, the locations of totally collapsed buildings, and half collapsed buildings that require major repairing are illustrated. The damage to buildings was concentrated in the Iioka district in the eastern part of the city. The authors surveyed Asahi City for the first time on March 18, a week following the earthquake. Figure 2 shows the survey route and photographs of damaged buildings. Many damaged buildings were observed along not only the coastline but also a road on the survey route, further away from the coastline.

Figure 1: Distribution of damaged buildings after tsunami in Asahi City, Chiba Prefecture

This study tries to obtain the statistics related to structural damage. Since the exact locations of the damaged buildings following the tsunami were available (see Fig. 1), a dataset of the actual damage could be established. Then, the damage ratios of the buildings in terms of the inundation depth, current velocity, and hydrodynamic force were evaluated by combining this dataset with the results of the numerical simulation. We consider the damage ratios only in Iioka district, in which damage to buildings was concentrated, because the result of our numerical

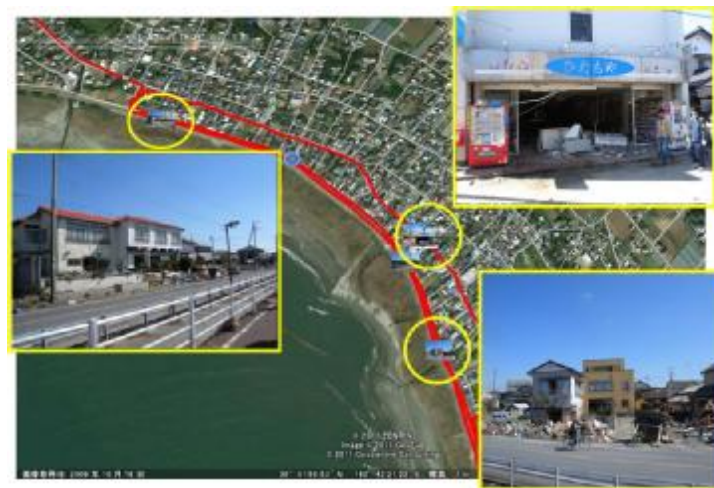
Figure 2: Survey route and examples of damaged buildings in Asahi City, Chiba Prefecture

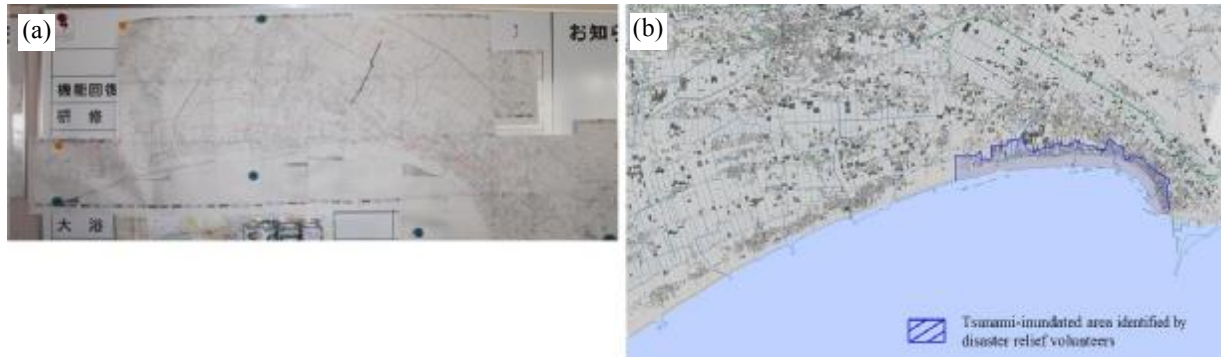
To confirm the areas inundated by tsunami, the authors visited Asahi City on three occasions and conducted field surveys and interviews. The map developed by the disaster relief volunteers showing the extent of tsunami inundation was provided by the city government during the second field survey conducted on April 12, 2011. The tsunami-inundated areas identified by the volunteers were highlighted on a city map (Fig. 3(a)). The authors obtained photographs of these maps and developed polygons demonstrating the tsunami-inundated areas. These were then projected onto a geographic information system (GIS) (Fig. 3(b)). The map mainly covered the Iioka district in the eastern part of Asahi City.

Figure 3: (a) Tsunami-inundated areas identified by disaster relief volunteers in Asahi City and (b) the identified areas projected onto a GIS system

The Geospatial Information Authority of Japan (GSI) has developed the tsunami inundation maps by interpreting satellite and aerial images taken after the earthquake (GSI, 2011). Figure 5 presents a comparison among the tsunami-inundated areas shown in Figs. 3 and 4 and those developed by the GSI. Overall, the areas of tsunami inundation on the three maps overlapped with each other in the eastern part of Asahi City. The three areas marked

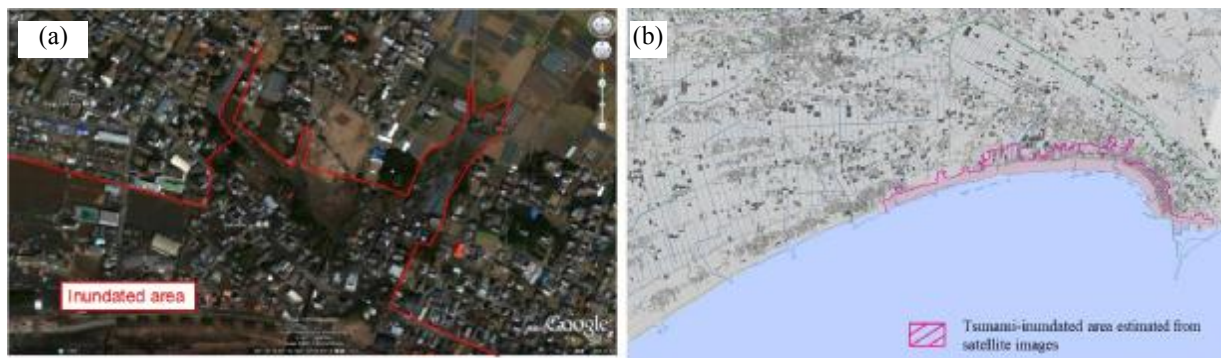
Remotely sensed imageries are effective tools for identifying the tsunami-inundated areas (Inoue et al., 2007; Kouchi and Yamazaki, 2007; Koshimura et al., 2009; Chen et al., 2005). To this end, critical information about the tsunami of March 2011 was resourced from Google Crisis Response (Google Crisis Response, 2011). The satellite images of the eastern part of Asahi City, captured by Digital Globe on March 12, 2011, were used. The quality of images permitted identification of the tsunami-inundated areas by visual inspection (Fig. 4(a)). The change in color on the ground was mainly used to identify the tsunami-inundated areas. Figure 4(b) shows the tsunami-inundated areas identified by the visual inspection of the satellite images.

Figure 4: (a) Example of visual inspection of satellite images to identify tsunami-inundated areas and (b) their visualization in GIS system

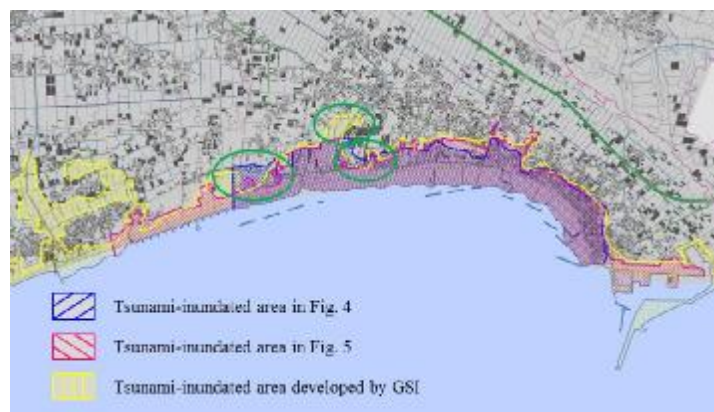
Figure 5: Comparison among the tsunami-inundated areas shown in Figs. 4 and 5 and those developed by GSI

with circles indicate sites where the estimates did not coincide. Hence, the authors revisited these sites on June 28, 2011, and interviewed inhabitants to reassess the tsunami-inundated areas. The final estimates of the tsunami-inundated areas are shown in Fig. 6. It should be noted that only the map developed by the GSI was available for the western part of Asahi City. The inundated areas in the eastern part could be validated from three different sources: the map drawn by the volunteers, the result of visual inspection of satellite images, and the tsunami inundation map developed by the GSI.

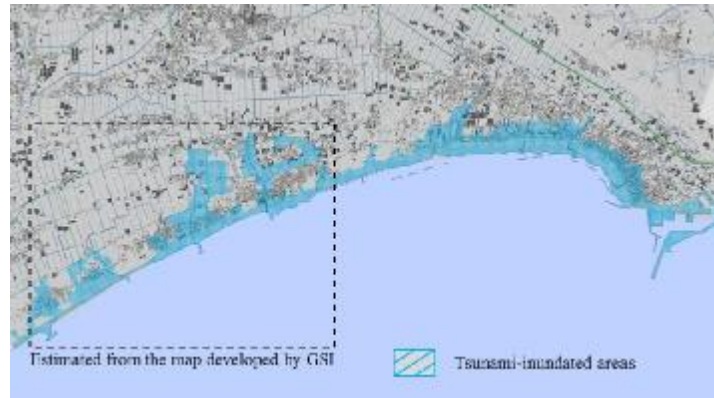
Figure 6: Final estimates of tsunami-inundated areas in Asahi City, Chiba Prefecture, after the 2011 off the Pacific coast of Tohoku Earthquake

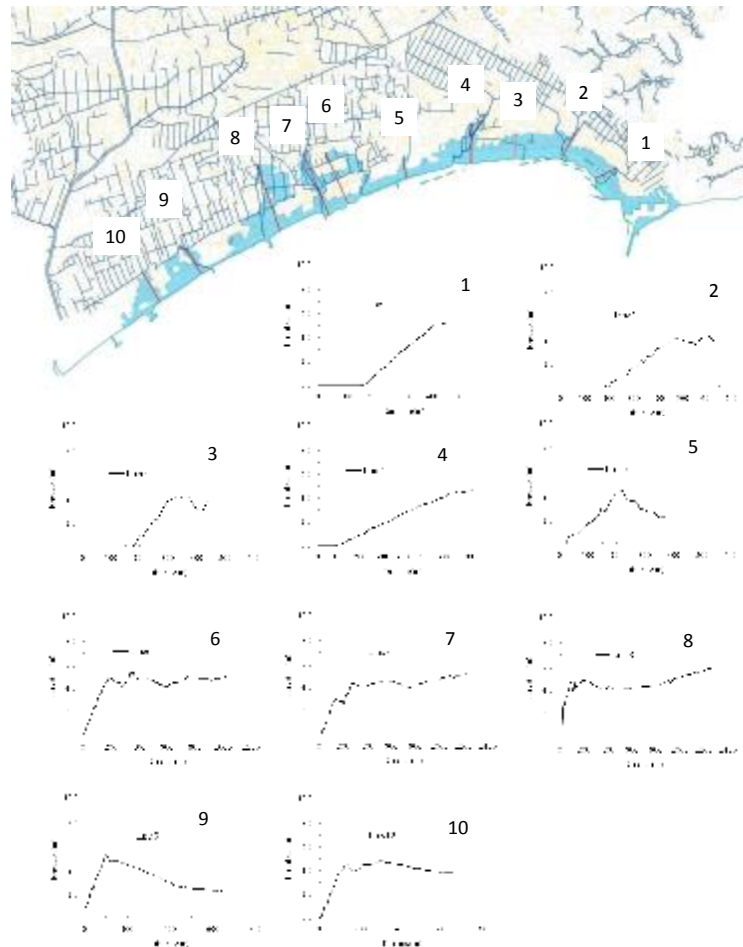
The authors set 10 traverse lines in the identified inundated area and the elevations were extracted along the lines (Fig. 7). The digital elevation model with a grid size of 10 m compiled by the GSI was employed in this study. The results show that the run-up reached a height of approximately 5 m in Asahi City, Chiba Prefecture.

Figure 7: Distribution of land elevations along the transverse lines in the identified tsunami-inundated areas in Asahi City, Chiba Prefecture

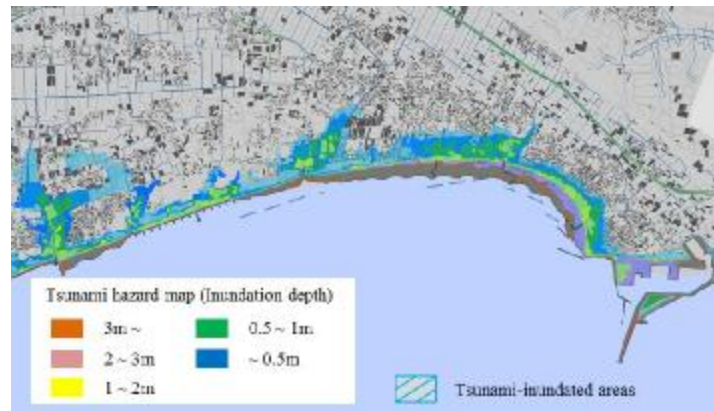
Tsunami hazard maps have already been developed for Asahi City (Asahi City, 2008). In these maps, the areas of tsunami inundation were estimated in the context of the 1677 Empo Boso-oki and the 1703 Genroku Kanto earthquakes (Iwabuchi et al., 2008). Figure 8 shows a comparison of a tsunami hazard map with the identified tsunami-inundated areas of the city after the 2011 Tohoku Earthquake. It can be observed that eastern parts of the

Figure 8: Comparison between tsunami hazard map and identified tsunami-inundated areas in Asahi City, Chiba Prefecture, after the 2011 off the Pacific coast of Tohoku Earthquake

city, such as Iioka, were affected more severely than expected. However, despite the installation of seawalls approximately 4 m in height in Iioka, the tsunami waves climbed over the walls and struck the residential areas.

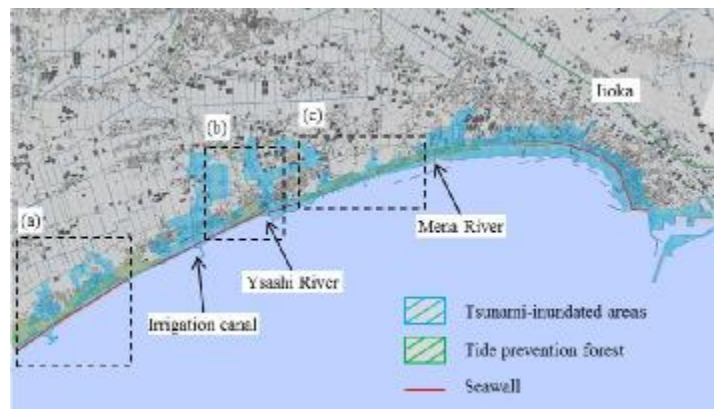
Figure 9: Land use classifications along the coast in Asahi City, Chiba Prefecture, and the tsunami-inundated areas

Land use classifications along the coast were interpreted from satellite images presented in Google Earth before the tsunami. The images were projected onto the map coordinate system, and the locations of tide prevention forests and the seawalls were manually identified (Fig. 9). It was observed that the tsunami-inundated areas spread mostly along the rivers. In general, the height of tsunami waves exceeded that of the seawalls. In the areas labeled (b) and (c), there are comparatively less inundations behind the tide prevention forests except for the areas along the rivers. There are both seawalls and tide prevention forests in the area identified as (a), but this region experienced tsunami inundation. The problem of tsunami inundation with mixed natural and artificial approaches to tsunami mitigation has mixed results. As a whole, the integrity of the trees was such that they were able to withstand the forces of the tsunami inundation, and there was a high enough density of trees that they minimized the inundation by tsunami in several areas. Overall, the ability of tide prevention forest to minimize tsunami inundation remains somewhat controversial because in Tohoku district, large areas of coastal forest failed to protect from the tsunami (EERI 2011a). In most cases, this was simply because the tsunami force was too large and the trees were destroyed. For Asahi City, Chiba Prefecture, the tsunami forces might be smaller and the trees survived, providing some measure of protection.

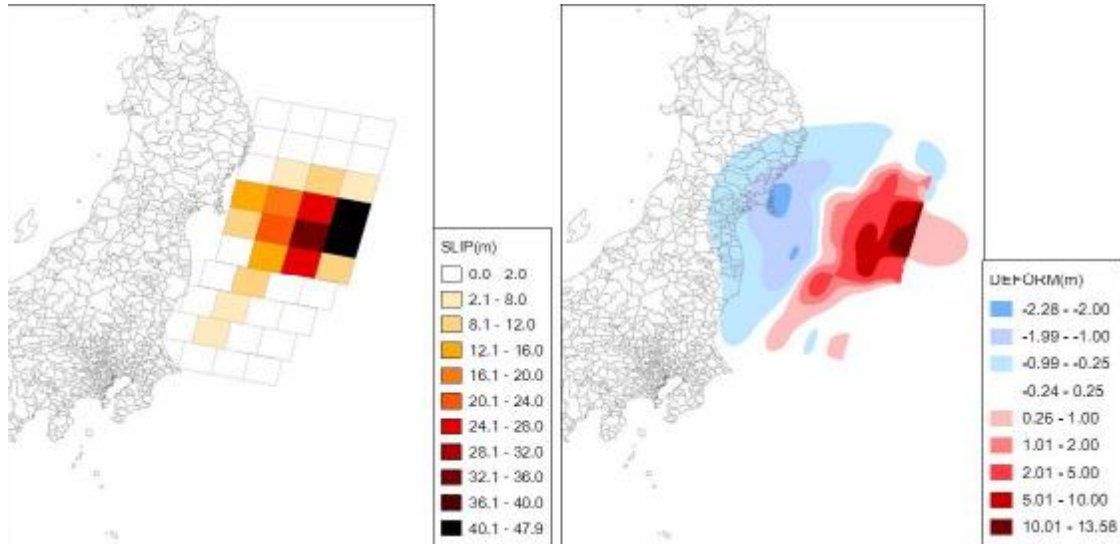
Numerical simulation of tsunami propagation was performed to estimate the tsunami-inundated areas in Asahi City. The seismic fault model developed by Fujii and Satake (2011) was employed to estimate the vertical displacement of the seabed. Figure 10 shows the fault model developed by Fujii and Satake (2011) (Fig. 10(a)) and the vertical displacement (Fig. 10(b)) estimated by Okada's method (Okada, 1985). Assuming the water

Figure 10: (a) Fault model developed by Fujii and Satake (2011) and (b) vertical displacement of seabed as estimated by Okada's method (1985)

layer to be incompressible, the estimated vertical displacement of the seabed was regarded as the initial profile of the tsunami.

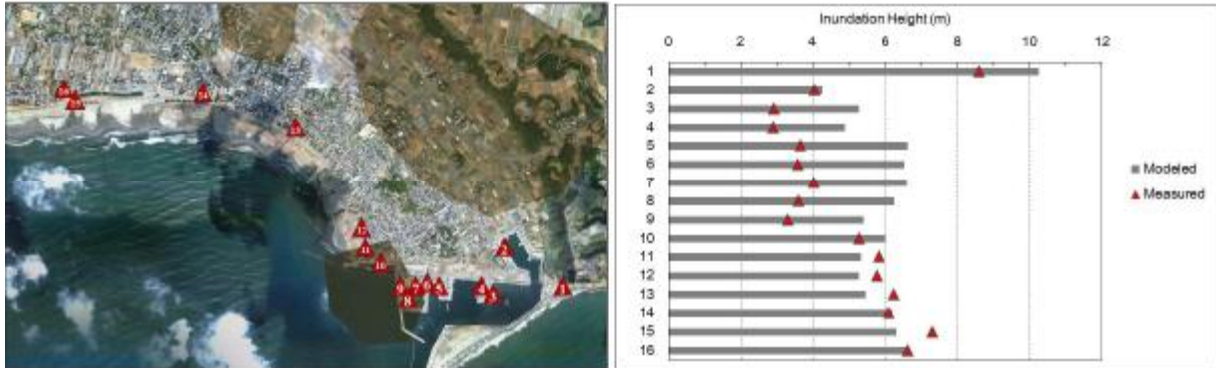
Figure 11: Comparison between the measured tsunami inundation heights and those estimated by numerical simulation in Asahi City, Chiba Prefecture

The simulation result was compared with the findings of tsunami surveys conducted by the 2011 Tohoku Earthquake Tsunami Joint Survey Group (2011). Figure 11 shows a comparison of tsunami inundation heights estimated by the numerical simulation with those surveyed in the eastern part of Asahi City. The locations of measurement points of tsunami inundation heights along the coastline compiled by the group are also illustrated in Fig. 11. The inundation height collected by the survey group is defined as the elevation of water level with reference to the sea level (Tokyo Peil: T.P.). According to the comparison, the estimated inundation heights show good agreement with the observations especially in the residential areas, which are labeled as 10–16.

simulation was verified as in Figs. 11 and 12. The hydrodynamic force applied to structures during a tsunami can be expressed as

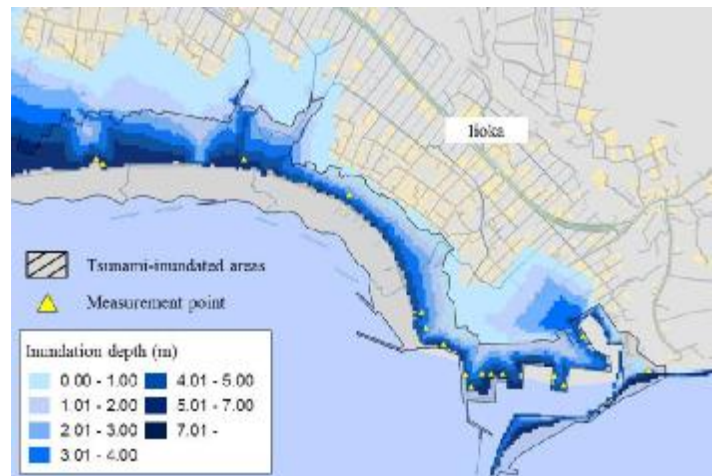
Figure 12: Comparison between inundation depths estimated by numerical simulation and the tsunami-inundated areas identified in this study

Figure 12 shows a comparison of the tsunami-inundation depths obtained by the numerical simulation with the tsunami-inundated areas identified in this study. We focus on the eastern part of Asahi City, where the inundated areas were verified through different sources. The simulated distribution of the tsunami-inundated areas and the distribution identified through our surveys show similar trends especially in Iioka district.

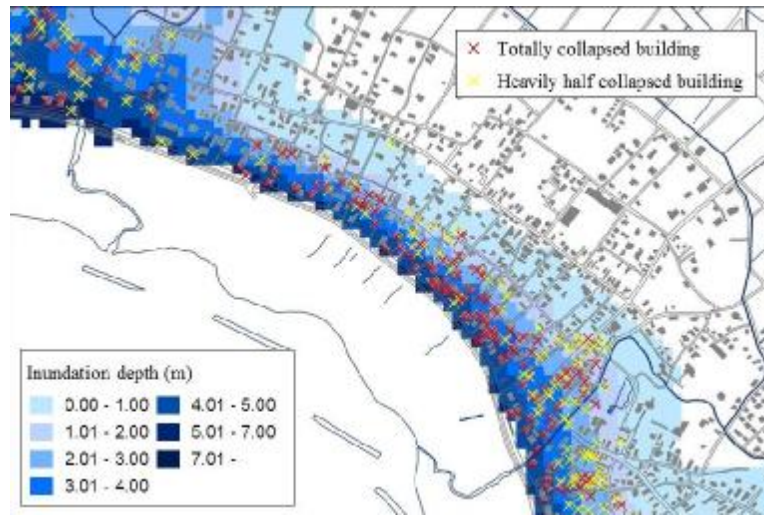
Figure 13: Distribution of damaged buildings according to estimated tsunami-inundation depths

Figure 13 shows the distribution of damaged buildings in the tsunami affected area according to the estimated inundation depths. Building inventory compiled by Zenrin, a Japanese map publisher, in 2009 was used in this study (Zenrin, 2012). Figure 14 shows the relationships between the damage ratio of buildings and the estimated tsunami-inundation depths, current velocities, and hydrodynamic forces. The figure also shows a fragility curve constructed after the 1993 Hokkaido-Nansei-Oki earthquake (Koshimura et al., 2010). In the study, pre- and post-event satellite images were employed to perform visual damage inspection. The buildings were interpreted as “survived” and “destroyed” by detecting the roofs were remained or not, and the fraction of “destroyed” buildings was used as the damage ratio. The damage ratios in Asahi City were in a similar level as those after the 1993 Hokkaido-Nansei-Oki earthquake with respect to the inundation depth. However, the damage ratios associated with the current velocities and hydrodynamic forces show smaller values than the estimations by fragility function. The tsunami vulnerabilities, such as topological conditions, structural characteristics, and so on resulted in these differences.

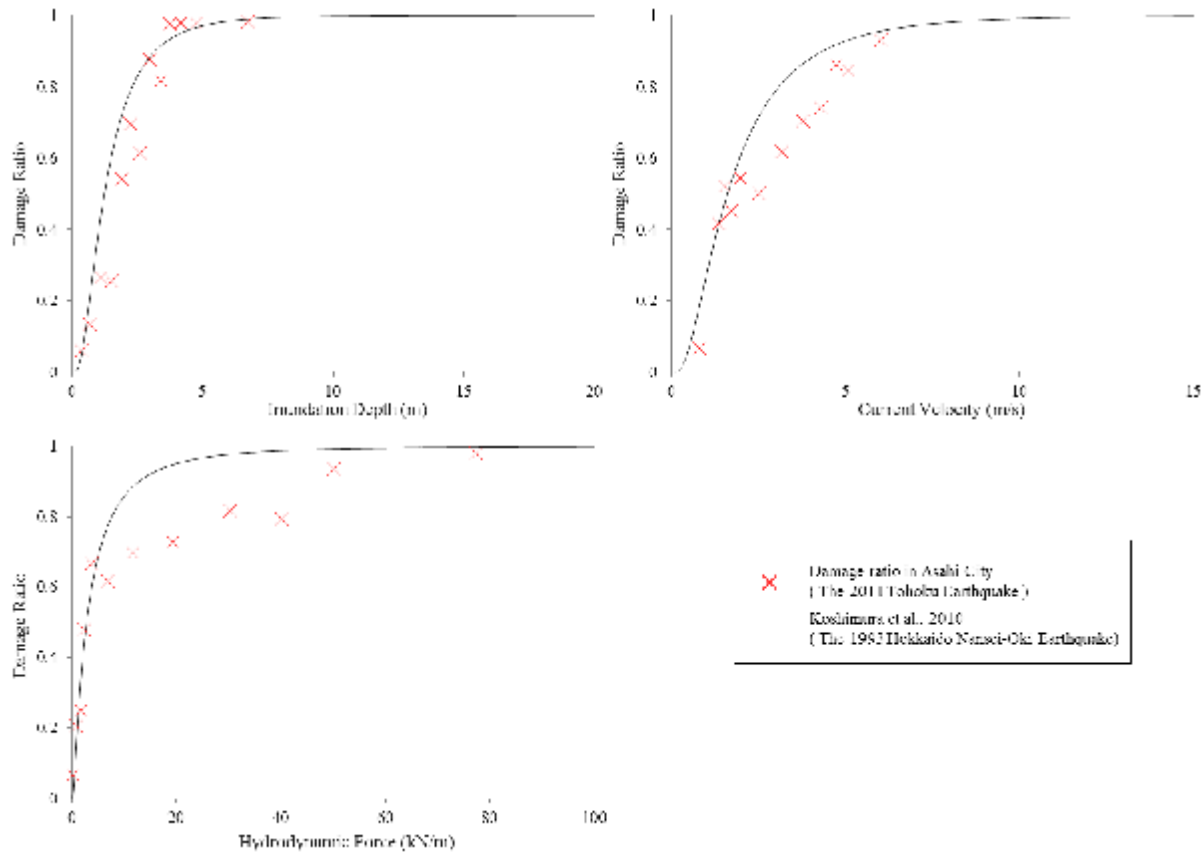
Figure 14: Damage ratios of buildings in Asahi City, Chiba Prefecture, with respect to the estimated tsunami-inundation depths, current velocities, and hydrodynamic forces

$$F = \frac{1}{2} C_D \rho v^2 d$$

where C_D is the drag coefficient, ρ is the density of water v is the current velocity, and d is the inundation depth.

According to the relationships between the damage ratios of buildings in Iioka district and the estimated tsunami inundation depth, current velocity, and hydrodynamic forces, the damage ratios with respect to the inundation depths coincided with those after the 1993 Hokkaido Nansei-Oki earthquake. Employing the fragility functions discussed in the paper, damage assessment of buildings in Chiba Prefecture will be performed in our future study.
