CRUSTAL DEFORMATION DETECTION USING CLOSE-RANGE PHOTOGRAMMETRY

KEY WORDS: Crustal deformation, Close-Range Photogrammetry

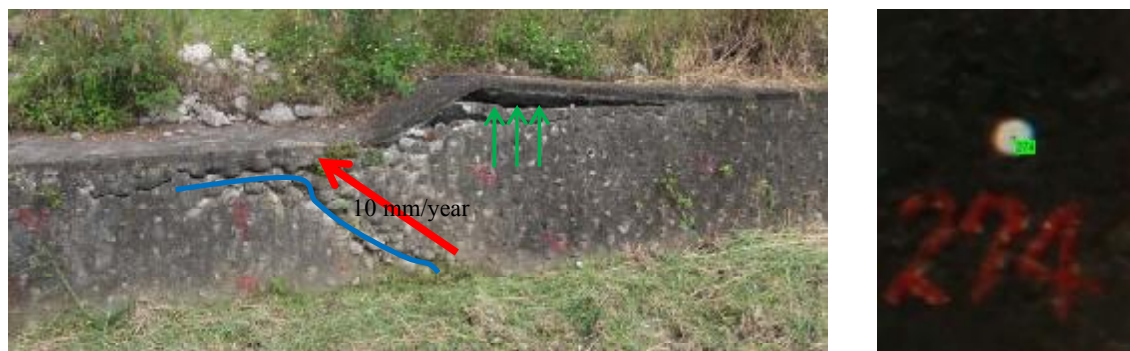
Figure 1 (a) Rupture surface and relative displace direction; (b) The permanent targets on the wall

The study site is near Guanshan Township in eastern Taiwan where a significant rupture on the concrete wall of a drainage channel is caused by the movement of Chihshang creeping fault. As shown in Figure 1 (a), the wall was constructed by pebble with concrete and some plants grow on it, one could also see the blue ruptured curve in the middle photo and uplift in the right hand side, where the red arrow means the relative movement direction about 10 mm/year in this region.

In order to monitor the relative displacement of this site, about 800 stainless nails are fixed in 5 rows by 160 columns on the wall surface as permanent targets, where the dimensions is 5m * 120m. In the meantime, to reduce the noise and increase the measuring accuracy during targets detection, the background has been painted in black with white circle target, an example shown in Figure 1 (b). Thus, the coordinates of these permanent targets could be estimates by taking photos and calculate their relative displacement by different time series data sets (one data set represents a series of photo taken in a time).

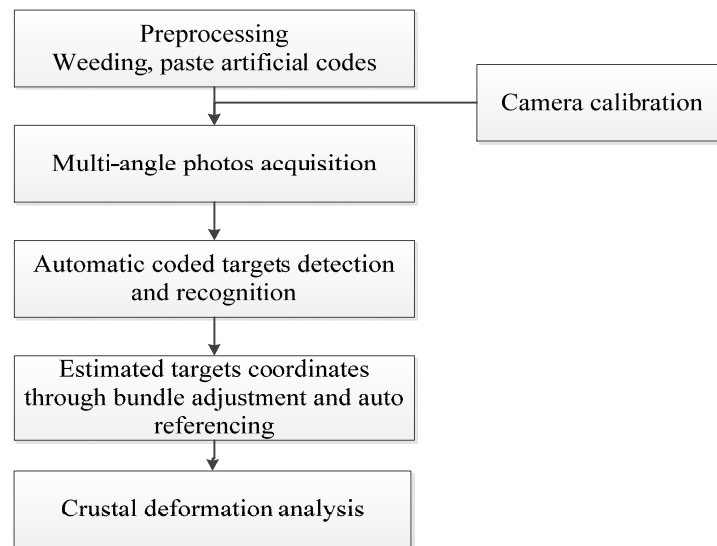
Figure 2 The flow chart for monitoring the displacement of crack by close-range photogrammetry

The workflow for monitoring the displacement of a ruptured surface caused by Chihshang fault is shown in Figure 2. In preprocessing stage, the wall needs weeding to reduce the occlusion area and patch the artificial coded targets on the wall surface. Before photo acquisition, the camera parameters should be well calibrated, then take the photos of the wall with multi-angle to get a good intersection angle. Then, the photos are imported into Australis software © for automatic coded target detection and recognition, and get the estimate coordinates of permanent targets through bundle adjustment and auto-referencing. Thus, we can calculate relative displacement by different time series of photos (separated with about one month). The details of each stage are described below.

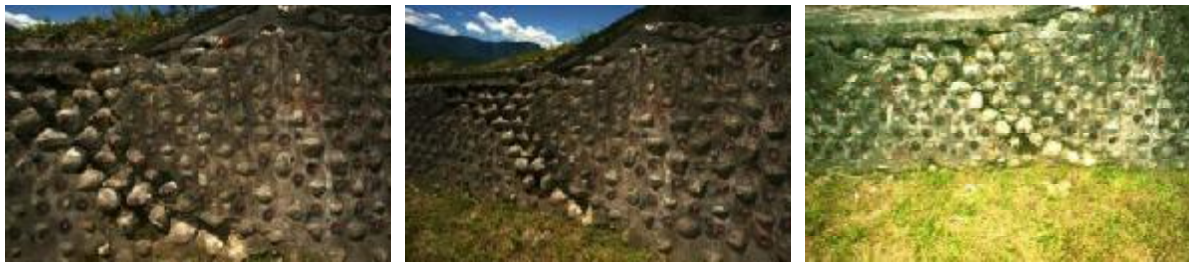
(a) Vertical (Orthogonal to the wall) (b) Oblique (leftward) (c) Oblique (downward)

Figure 5 (a)-(c) examples of images taken from different directions

To automatically detect the coded targets and reduce noise effect in Australis software ©, the photos are taken under less sun light condition using flash light, which could acquire a high contrast images. In the meantime, to increase the tie-point connection of the imaging geometry, the multi-angle images are taken from vertical direction to the wall and four oblique directions (i.e. upward, downward, leftward and rightward) to increase the convergent angles. Examples of photos taken in different directions are shown in Figure 5 (a)-(c).
