APPROACHES FOR MITIGATING FLOOD DISASTERS UTILIZING REMOTE SENSING INFORMATION

Tadashi Sasagawa
PASCO CORPORATION, 1-1-2 Higashiyama, Meguro-ku, Tokyo 153-0043, Japan
Email: taawda5004@pasco.co.jp

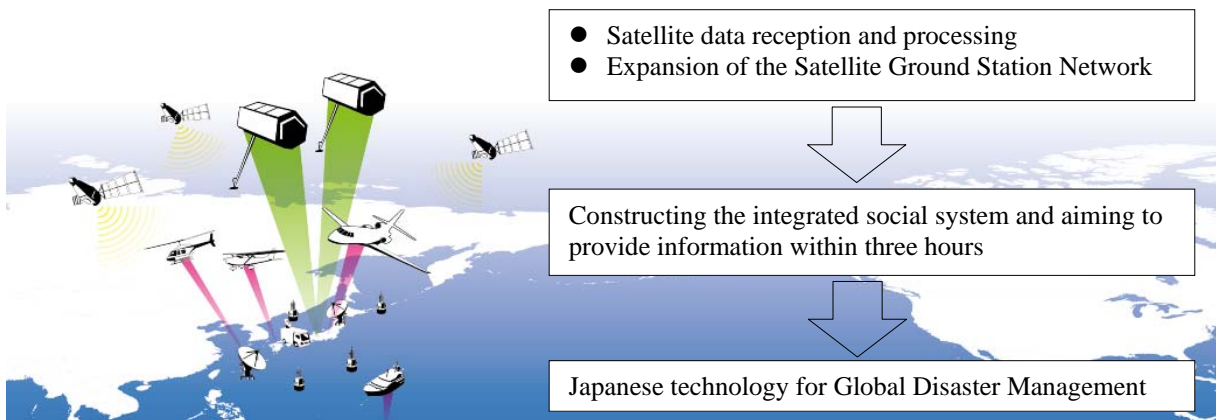
Figure 1. Approaches for mitigating disasters.

- Observing wide area information and creation of 3D data
- Speedy day/night observation and data creation
- Data creation for observing narrow area with higher accuracy
- Quick analysis of acquired data from various sensors, its visualization and provision
- Data relay and immediate processing in the areas after occurrence of a disaster

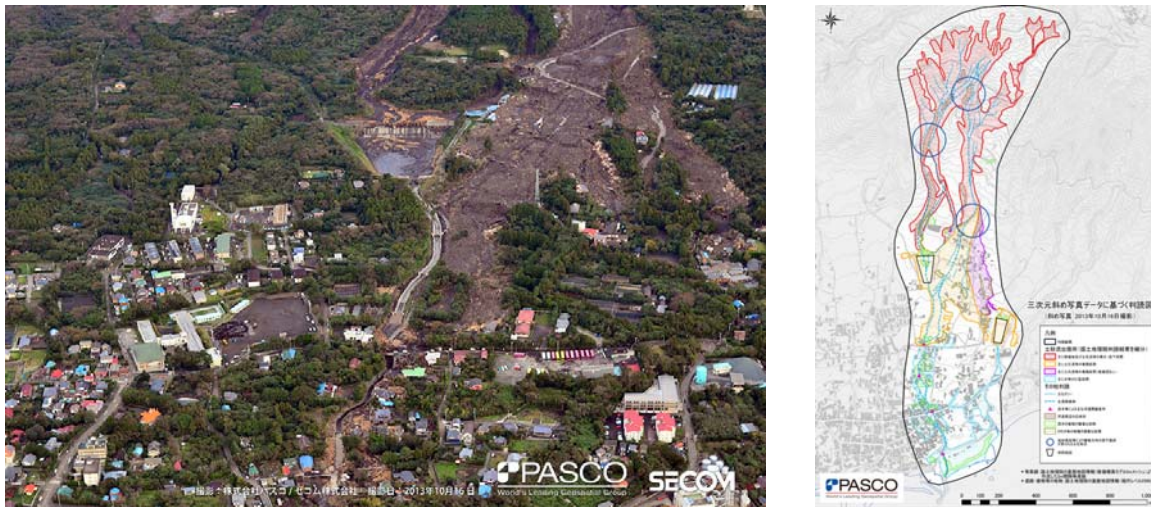
because the system records the direction of the photograph and center location of the objects and camera position simultaneously when shooting. A 3D model was created based on data from the PALS shot on Wednesday, October 16, 2013 (Figure 4). Status of damages was determined from 3D modeling*.

Figure 4. Oblique aerial photographs taken on October 16, 2013 (from the PALS). Statuses of damages were determined from 3D modeling.

Oblique aerial photographs were also taken on October 16, 2013 (from the PALS). The PALS was specially designed and developed by PASCO to take oblique photographs. Images can be immediately uploaded to GIS after landing

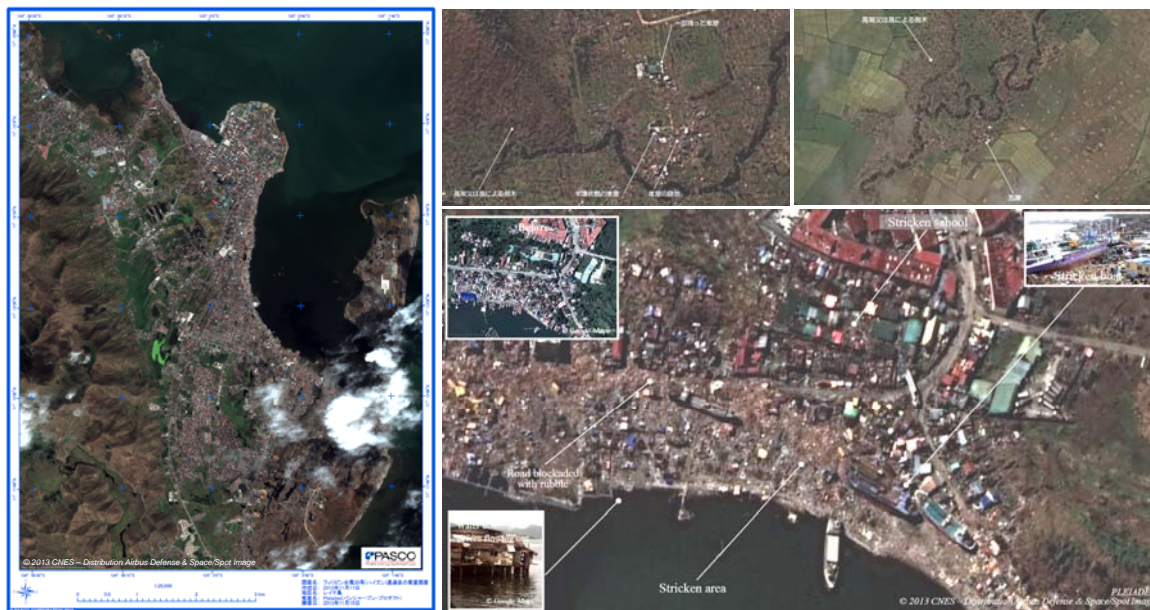
Typhoon Yolanda/Haiyan caused huge damage on November 8, 2013 in the Philippines. The estimated destructions were more than 1 million houses in the region and one of the deadliest natural disasters on record in the country. PASCO acquired high resolution imagery of the Pléiades satellite on November 15, 2013. The aftermaths of the destructions are visible in the enhanced images (Figure 7). Reports were prepared urgently and provided to the Embassy of Japan in the Philippines.

Figure 7. Pléiades imagery after the disaster and some conducted interpretations of the damages.
