# EARTHQUAKE DISASTER AREA EXTRACTION BY MACHINE LEARNING

Jonggeol Park<sup>1</sup> and Youngjoo Kwak<sup>2</sup>

**KEY WORDS:** Earthquake, Machine learning, Object-based analysis, Disaster area, GeoEye-1

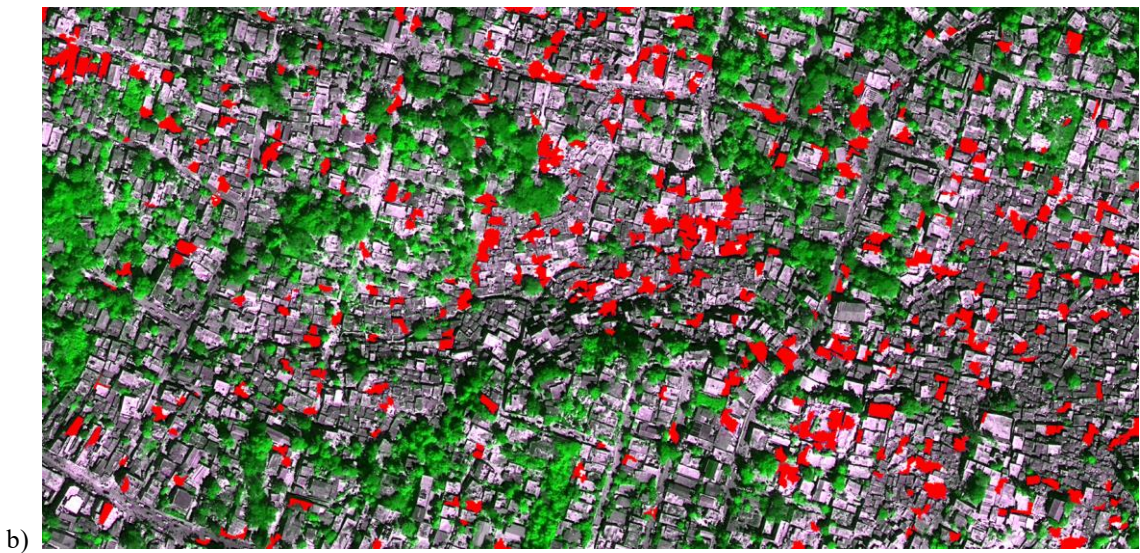
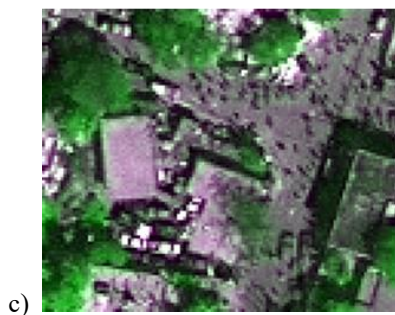
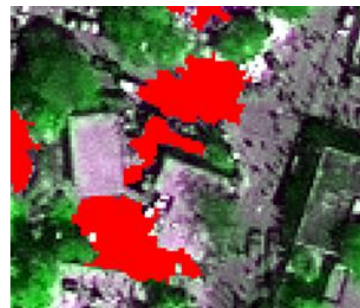
Figure 2. Overall image of the disaster area

We identified damaged buildings using equation (1) and the features obtained from the two-step hierarchical region segmentation. Figure 2 shows the images of three different affected areas before and after the earthquake including the images with objects having an EQDG of 1.4 or lower.

a) overall image b) disaster area detection (red area) of figure 11a by equation (1) c) zoom image of road with numerous people and parking lot d) miss identified as a damaged building of figure 2c

Figure 2a is an overall image of the disaster area. The disaster area was near the coast in the city of Port-au-Prince,

the capital of Haiti. Spaces between buildings were narrow, and the old town district consisted of many small buildings. Many people had collected on the streets following the quake. Figure 2b shows an area determined by Equation (1) to be a damaged area ( $EQDG > 1.5$ ). This indicates that the analysis correctly identified an area where concrete buildings had collapsed. Figure 2(c and d), on the other hand, shows an example where the analysis incorrectly identified a damaged area. Numerous people on the road registered as a large number of sub-objects that the system misinterpreted as debris.
