GEOPHYSICAL CHANGES DETECTION BY REMOTE SENSING IN ALAMINOS RIVER PANGASINAN, PHILIPPINES

ABSTRACT: Geophysical changes of the river outlets, riverbanks and coastlines in Alaminos, Pangasinan were measured using Google Earth from 2009 to 2014. On the other hand, actual measurements were gathered using South Total Station (NTS-362R6L) in 2015. The insight of the residents regarding feature changes of the river were obtained through one on one interview. Root Mean Square Errors (RMSE) were computed for measurement and horizontal positional accuracy of Google Earth. To perceive the effects of sea levels, historical data (2004-2015) from Bolinao, Philippines Tide Chart at online tides and currents predictions were also analyzed. Alaminos river outlets decreased in width size due to natural factor and human activities. Alaminos riverbank increased in width size which could be possibly due to natural calamities and weak bank resistance brought about by the frequent flooding caused by heavy rains and the emergency released of water from San Roque Dam. Generally the north and south coasts of Alaminos River increased and expanded. Rise in sea level is also a probable cause of changes where

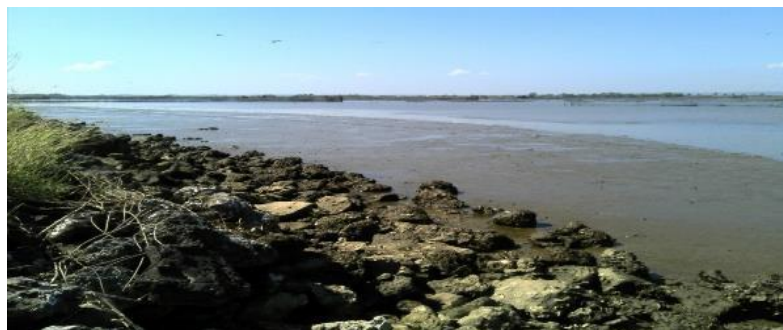
Figure 1. Alaminos River Outlets A and B and their changes over the years

The Alaminos River has two main outlets labeled as "Outlet A" and "Outlet B". Outlet A has minimal changes, from 193m in 2009 it narrowed down to 189m in 2014 and then widens to 191m in 2015 as from the data gathered in the field validation. Outlet B remained unchanged at 299m in 2009 to 2014 but did change a little in 2015 with the width of 300m (Figure 1). These Minimal changes and maintenance of the land area near the river mouths might be the result of manmade infrastructures like salt beds and fish pens made of solid rocks and soil further hardened with vegetation (Figures 2 & 3).

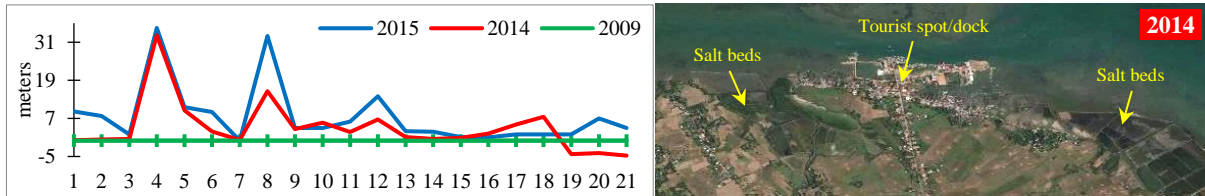
Figure 4 shows the changes occurred at the north coastlines of Alaminos River from 2009 to 2015 with the latest satellite image captured in 2014. Majority of the changes were dominated by accretion. Vegetation and manmade developments specifically for livelihood purposes have caused the changes in this area.

Figure 4. North Coastlines of Alaminos River

The north coastlines of Alaminos is highly utilized for tourism. Although salt beds are can be found throughout this area, tourism is the main source of living in this part of the coast specifically in Lucap in which the famous “Hundred Islands” is located.

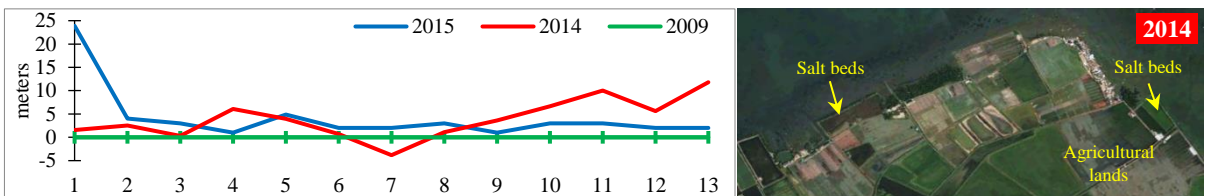
Figure 5 shows the alteration in the south coastlines of Alaminos River from 2009 to 2015 also with a satellite image taken in 2014. Overall, the data indicates that the land in this area has expanded from 2009 throughout 2015.

Figure 5. South Coastlines Alaminos River

The south coastlines of Alaminos River consists mainly of salt beds followed by fish pens, agricultural lands and very few communities. Salt is one of the primary sources of livelihood in the province of Pangasinan. According to the website ^[3]All about Alaminos City, etymologically, the term Pangasinan means the "place where salt is made", owing to the rich and fine salt beds which were the prime source of livelihood for the province's coastal towns.

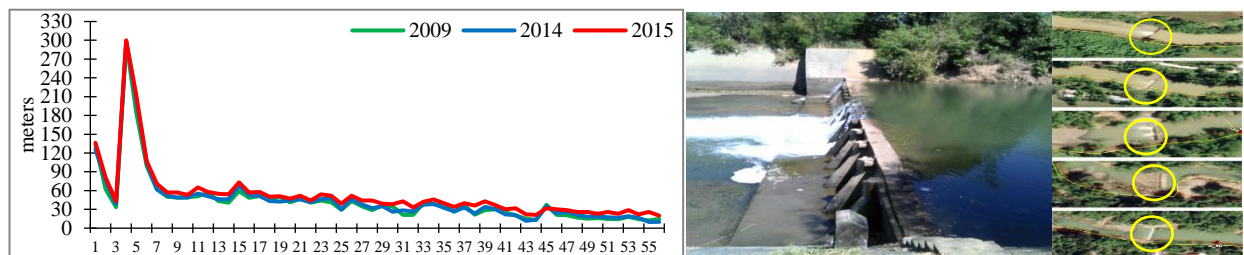
Figure 6. Alaminos Riverbank

Dams were also constructed (as shown in Figure 6) at the upstream to control the water level that is being used for agricultural crop production purposes in which rice is the most dominant crop as recorded by the ^[4]Comprehensive Land Use Plan 1999-2004 of the Local Government Unit of Alaminos City.

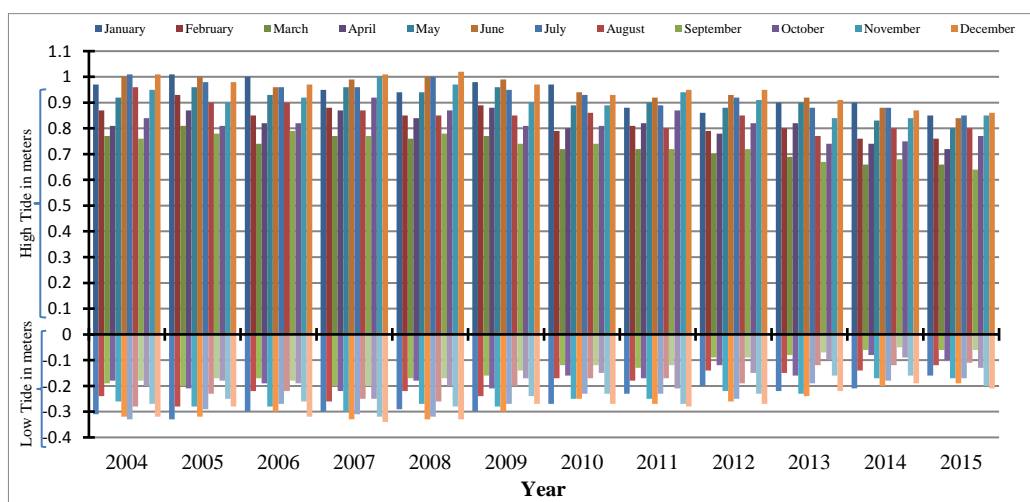
The graph shown in Figure 7 is a decade collective data from Bolinao Philippines tide chart at^[8] Online Tides WorldView. It provides tide predictions for over 7000 places around the world. Bolinao tide table-peak measurement predictions per year which represent the tide level measurements in the coastal areas of Pangasinan depicted that, average level of low tides in Pangasinan Gulf is increasing overtime. The average low tide in 2004 (-0.098 m) and the average low tide in 2015 (-0.045) had an average difference of 0.053 meter in terms of water level. The water level in the recent years (2013, 2014 & 2015) is nearer to land area than in the year 2004. However, the level of high tides in the year 2010 to 2015 is lower than in the year 2004 to 2009. As the level of low tides increases, the level of high tides decreases.

Figure 7. Tide table-peak measurement per year at Bolinao, Pangasinan
