## Disaster Area Detection by Deep Learning using UAV and Satellite Imagery

**KEY WORDS:** UAV, satellite imagery, object detection, YOLO, landslide

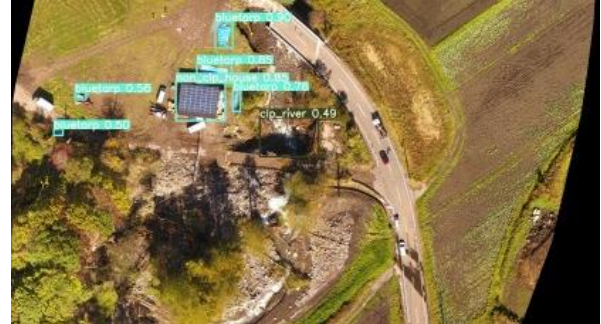
**Fig. 2.** Flood damage detection result.

In Figure 2, one flood damage location is detected in the vicinity of the bridge. However, the flood damage location in the lower part of the bridge was not detected. While most of the houses and blue tarps were detected correctly, some solar panels were incorrectly detected as houses.

Detection results from orthomosaic images of landslides and flood damage area are shown in Figures 1 and 2, respectively.

The results in Figures 1 and 2 show that the model learned from the drone image train data can detect the affected area in the orthomosaic image. Next, as another disaster site, we obtained aerial photographs of the Azumagawa area of the 2018 Hokkaido earthquake from Geographical Survey Institute maps and attempted to detect landslides. The results are shown in Figure 3.

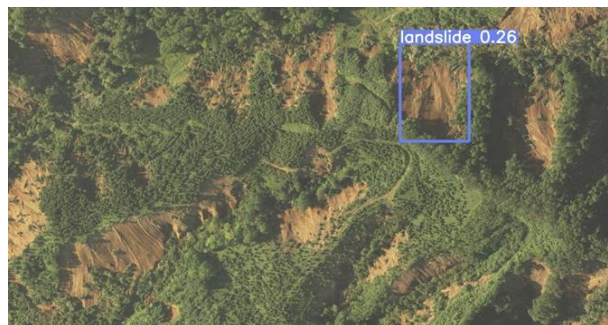
**Fig. 3.** Landslide detection result from 2018 Hokkaido Iburi Eastern Earthquake.

In Figure 3, there are several landslides, but only one landslide could be detected. The following factors may be responsible for the low detection rate.

- The training data used to create the model was based on landslides caused by typhoons, whereas the Hokkaido landslides were caused by earthquakes, resulting in different colors of exposed ground.
- Difference in the scale of the landslides.
- Difference in image resolution.
