Earthquake disaster investigation using a Compact MMS

Abstract On January 1, 2024, the Noto Peninsula in Ishikawa Prefecture, Japan, was struck by a magnitude 7.6 earthquake, known as "The 2024 Noto Peninsula Earthquake." This earthquake was one of the largest inland earthquakes in Japan, and caused extensive damages. Immediately after the earthquake, we conducted aerial photography and LiDAR surveys to assess the disaster. The acquired data revealed wide-spreading earthquake damages including landslides, road damages, and building collapses. However, there were limitations in identifying more detailed damages like road bumps and building tilts from the air. Therefore, in this study, a portable and easily deployable vehicle-mounted laser surveying system (MMS N-QUICK) was used to acquire high-density 3D point cloud data from the ground to grasp detailed damage conditions. As a result, the data enabled the quick identification of detailed ground damage, such as road damage and building destruction, which were difficult to assess through aerial surveys. This outcome allows us to complement the aerial survey results and achieve a comprehensive understanding of the damage.

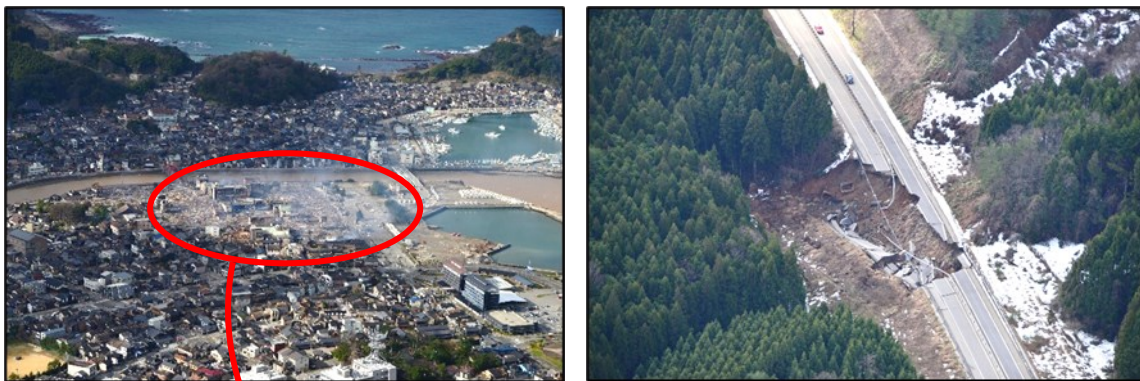
Figure 1: Oblique Photography Results

To assess the disaster, Nakanihon Air acquired oblique aerial photographs the day after the earthquake and conducted aerial LiDAR survey four days later. The oblique photographs provide an intuitive understanding of the situation in the affected areas while the aerial LiDAR data capture the three-dimensional surface details. Through these aerial surveys, the full extent of the earthquake damages including landslides, road damages, and building collapses throughout the region became clear.

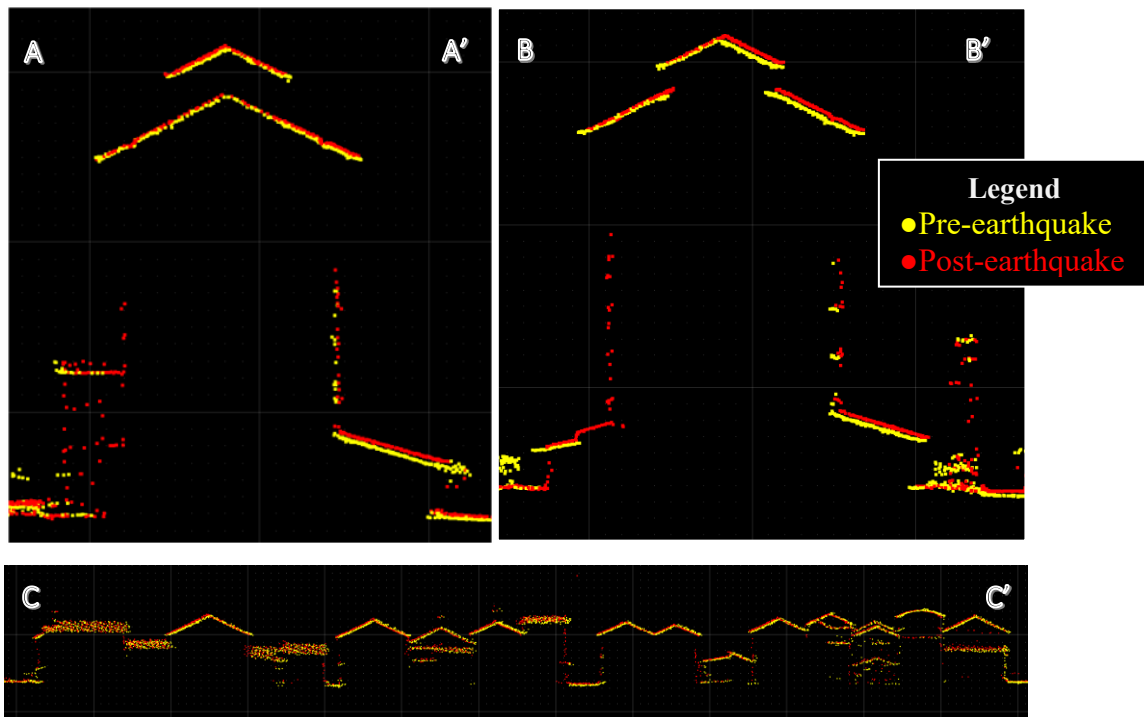
Figure 6:

Comparison of Cross-Sections of Point Clouds from Two Periods Using Aerial LiDAR Data

To verify the buildings discussed in the previous chapter, a visual on-site inspection was conducted. Then, it was found that the inclination of "Building A" and "Building B," shown in Figure 1-6, are different. However, it could not be determined which the building had the anomaly. Normally, accurately assessing the inclination of a building requires entering the building and using tools like a spirit level or laser level for measurement.

Upon examining the sides of "Building A" and "Building B" in Figure 1-6 using LiDAR data acquired from the Compact MMS, it was found that "Building A" was tilted by approximately 0.8 degrees, while "Building B" was found to be normal. In the cross-sectional comparison of the two periods of the aerial LiDAR data, the roof shape of "Building A" was almost identical in both periods, whereas a significant discrepancy was observed in "Building B," and they lead to the prediction of some anomaly. However, it is now believed that the roof displacement of "Building B" was likely due to the movement of the ground throughout the entire area. The Compact MMS is capable of acquiring dense 3D point cloud data of building sides, which are difficult to capture with aerial LiDAR surveying, and allowing for the detection of subtle tilts without stepping into the building. On the other hand, no abnormalities were detected in the LiDAR data derived from the Compact MMS for the group of buildings labeled "C." It is possible that the data from the Compact MMS may struggle to detect subtle tilts in low-rise residential buildings with one to two stories.

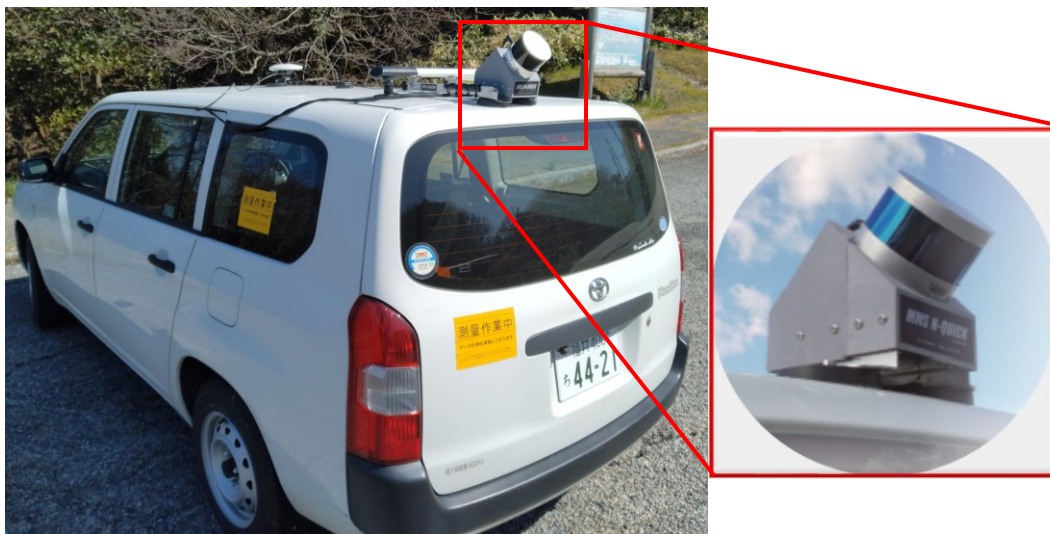
Figure 7: MMS N-QUICK developed by Nakanihon Air

To avoid those risks, an alternative and complement way to visual on-site inspections was conducted using "MMS N-QUICK," a system developed by Nakanihon Air. "MMS N-QUICK" is a portable and compact Mobile Mapping System (MMS): "vehicle-mounted laser surveying system", that compactly integrates a "laser measurement device," "camcorder," "GNSS device," and "IMU (Inertial Measurement Unit)." This equipment can densely acquire three-dimensional point cloud data of roads and surrounding terrain and structures.

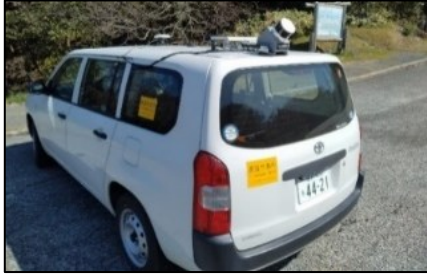
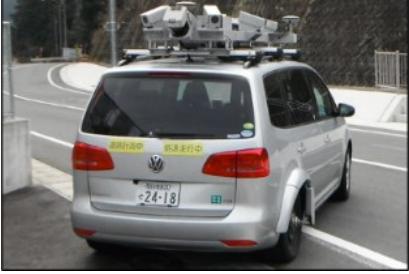
Figure 8: Comparison of MMS N-QUICK and Conventional MMS

Detachment/ Transportation	Easy (due to magnetic detachment system)	Difficult (due to being fixed to the vehicle)
Vehicle Types	Almost any vehicles	Limited to specific vehicles
Measurement Accuracy	RMS: less than 0.25m	RMS: less than 0.25m
Product Price	From approx. 40,000 USD	Approx. 200,000 USD to 750,000 USD
# of Operator	One (a driver only)	Two (driver and operator)
Mounted Sensors	One laser measurement device, one camera	Multiple laser measurement devices, multiple cameras
	All-weather	Basic waterproofing

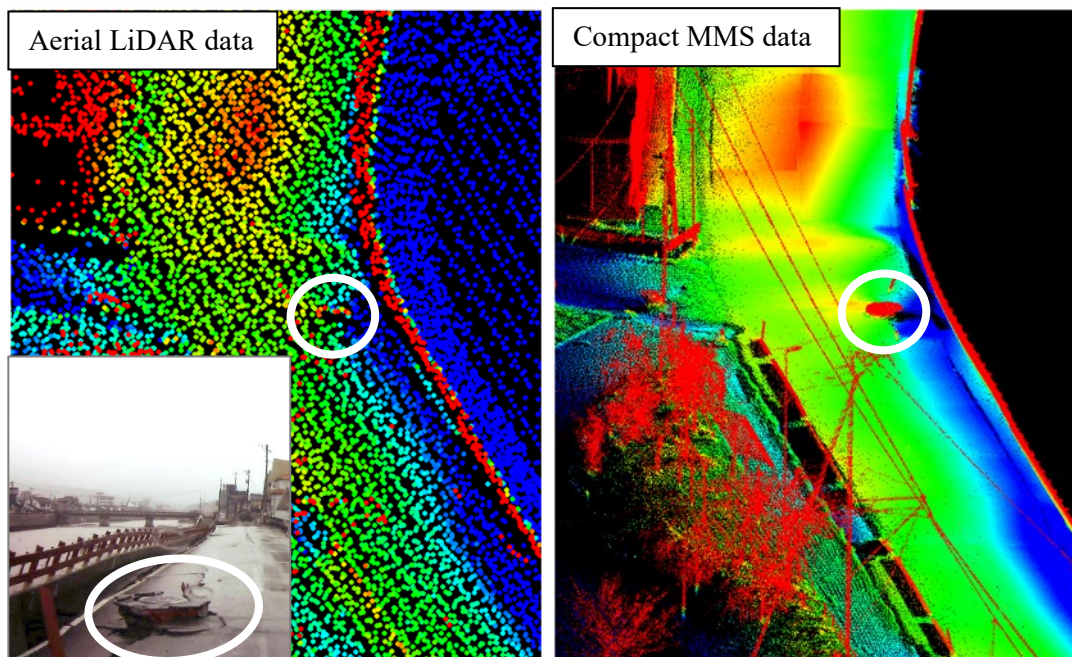
Figure 11: Bird's-Eye View of the Point Cloud

On the other hand, the single period LiDAR data from the compact MMS could detect manhole protrusions and spotting subsidence on the roads (Figure 3-2). While such road damages may be less noticeable compared to large-scale disasters like landslides, they have a significant impact on daily life and recovery efforts. The combination of rapid measurement over a wide area by aerial survey and high-density data acquisition by the compact MMS reveals various possibilities that were not visible before.

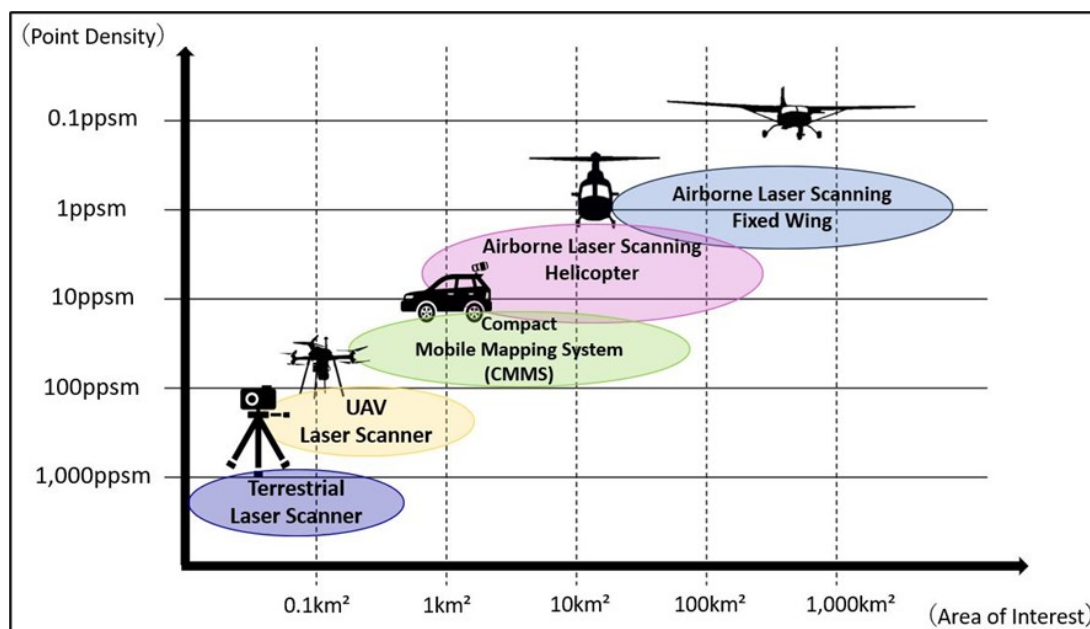
Figure 12: Comparison of LiDAR Measurement Methods

Aerial surveying is an indispensable method for understanding the full extent of earthquake damages, as it allows for rapid measurement of large areas without being affected by ground conditions. However, aerial surveying is heavily dependent on weather conditions, and due to the measurement from the high altitude, such investigations required very details like the sides of buildings are challenging because the acquired data are not dense enough.

On the other hand, surveying with the compact MMS, which uses vehicles, is more susceptible to road conditions, and the survey area is limited to roads and their surroundings. Nonetheless, it provides a cost-effective way to quickly assess detailed ground damages, such as road conditions and buildings. It serves as an optimal method to complement aerial surveys effectively.
