A Cloud-Based System for Monitoring Water Quality in Tuul River from Space

Abstract: *The Tuul River is an essential water source for the water supply and ecological sustainability of Ulaanbaatar. In this study, using Sentinel-2 satellite imagery data from April 21, 2025, the water quality of the Tuul River was assessed using physical parameters such as turbidity, color, and hydrogen ion concentration in accordance with national standards such as MNS ISO 5667:2001, MNS 0900:2018, MNS 4586:2024, and MNS 3900:1986. For this purpose, the Modified Normalized Difference Water Index (MNDWI), the Normalized Difference Turbidity Index (NDTI), which indicate the state of water quality, were calculated. The results of the field survey conducted on April 20, 2025 were compared and verified with the results of physicochemical measurements and analyses taken within the framework of the “Water Quality Study of the Tuul River in the Ulaanbaatar City Area” project implemented by the “Institute of Chemistry and Chemical Technology” in 2021. Using the Google Earth Engine platform, it was demonstrated that large amounts of data can be processed over a wide range of space and time, regardless of comp

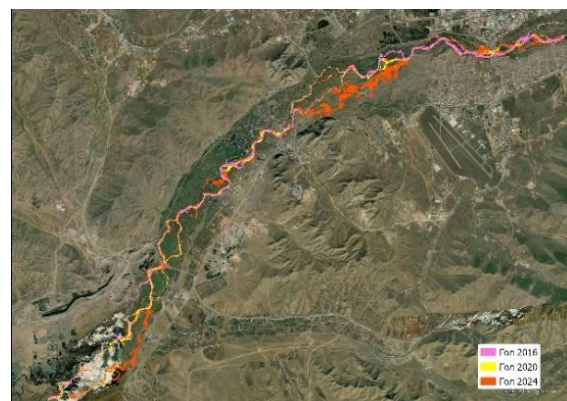
Figure 6: Flow of the Tuul River in 2016, 2020, and 2024

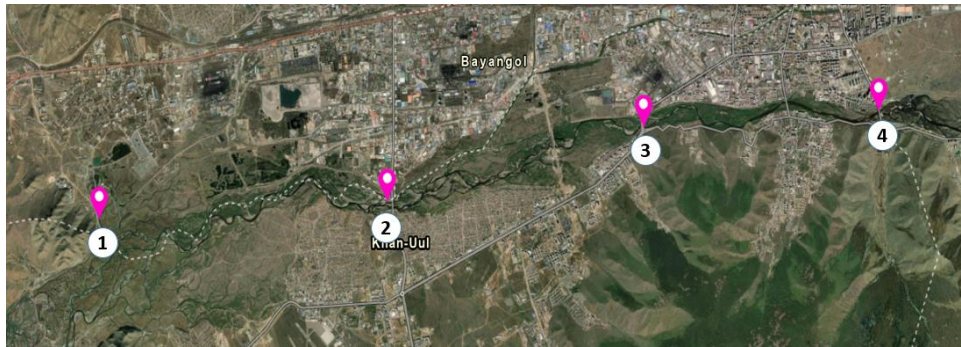
Figure 14: Location of the Four Sampling Points

Field sampling was conducted in accordance with the MNS ISO 5667-6:2001 standard. On April 20, 2025, water samples were collected from the Tuul River to determine key physical water quality parameters, specifically turbidity and color, and to validate the results obtained from satellite-based calculations. Sampling was carried out at four monitoring points used by the Water, Meteorology, and Environmental Monitoring Agency for seasonal river water quality measurements, allowing a direct comparison between field observations and remote sensing data.

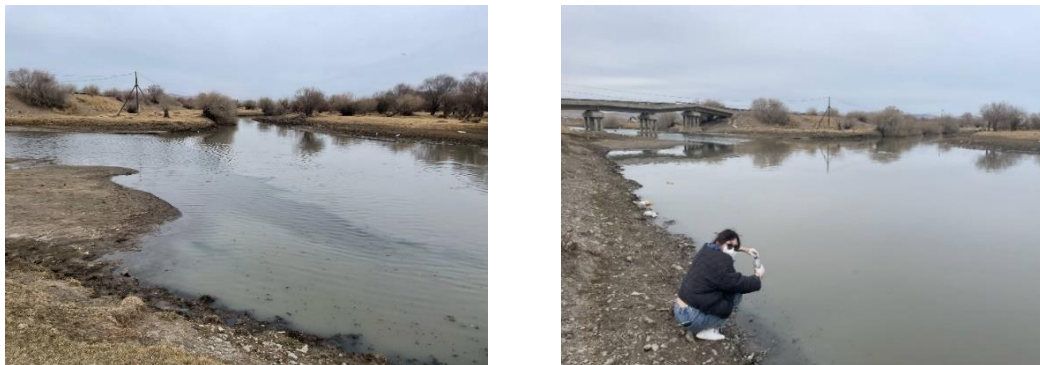
The first sample, taken just downstream of the Central Wastewater Treatment Plant, showed clear signs of pollution. The water had a strong odor, appeared dark and turbid, and contained floating debris, suggesting incomplete treatment and poor water quality. Further chemical and biological analysis is needed to assess pollution levels and evaluate the plant's treatment efficiency.

Figure 15: Sampling Process near the Central Wastewater Treatment Plant (CWTP)

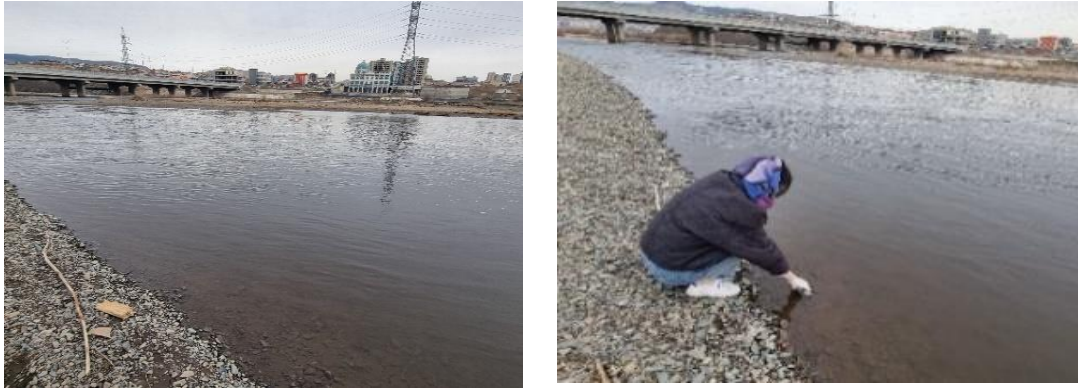
The second sample, taken from the right bank of the Tuul River near Sonsgolon Bridge, showed relatively better water quality than the area near the wastewater treatment plant. No foul odor was detected, and the water had a natural brownish color, though it remained turbid and cloudy—likely due to soil runoff, human activity, or sediment accumulation in slower flow areas. Further chemical analysis is needed to confirm these observations and assess water quality more accurately.

Figure 16: Sampling Process near Songgol Bridge

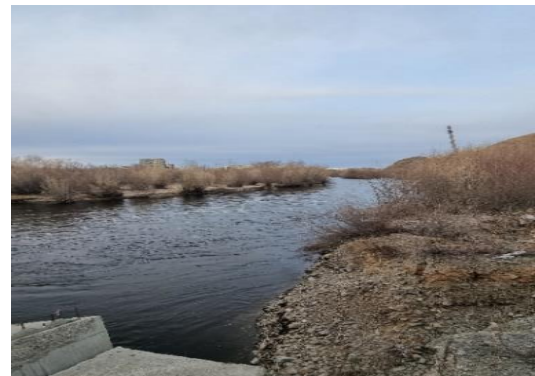
The third sample was collected from the section near Yarmag Bridge. This area is not directly influenced by the Central Wastewater Treatment Plant, and as such, no unpleasant odors were detected, indicating a relatively clean environment. Compared to the section near Songgol Bridge, the water appeared slightly lighter brown and only mildly turbid. Overall, no significant pollution was observed in terms of odor or color.

Figure 17: Area Surrounding Yarmag Bridge

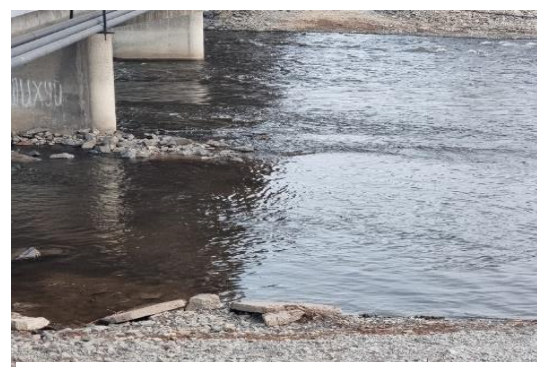
The fourth sample was collected near Marshal Bridge along the Tuul River. Compared to areas near the Central Wastewater Treatment Plant, water quality conditions at this location were more favorable. No unpleasant odors were detected from the water, and no surrounding factors were observed that could negatively impact air quality in the vicinity.

Figure 18: Area Surrounding Marshal Bridge

In terms of color, the water near this section was slightly brown compared to the area around Songgol Bridge, which is consistent with natural conditions. The river flow was relatively

stable and moderately strong, potentially supporting the self-purification capacity of this section. Overall, the surrounding environment was relatively simple, and sampling was conducted without major difficulties.

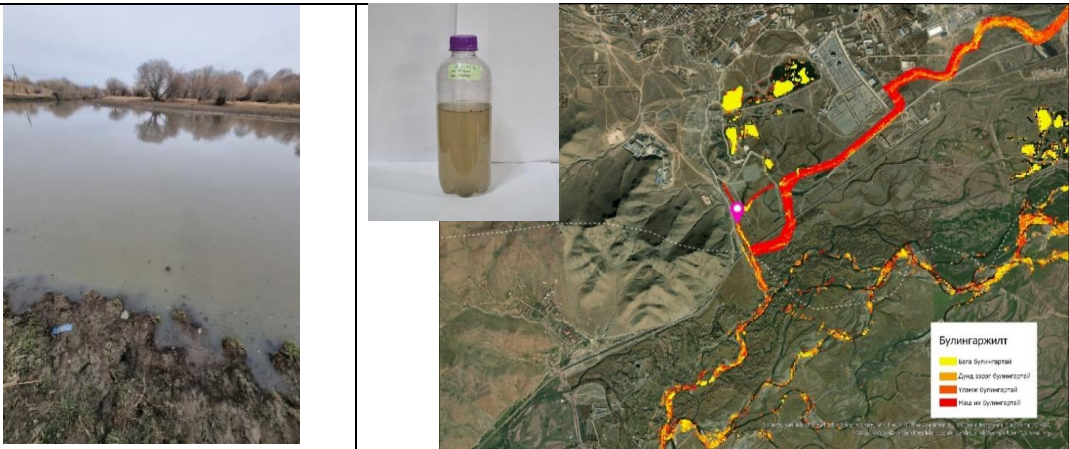
Table 2: Sampling Point 1

Parameter, Unit	Color	pH
	Permissible Limit (MNS 4586:2024)	20	6.5 – 8.5
	Measured Value in Tuul River	150	10
<p>Note: The physical water quality parameters, including color, turbidity, and hydrogen ion concentration (pH), were assessed based on the permissible limits set in MNS 4586:2024. The water sample collected near the Central Wastewater Treatment Plant exceeded these limits. The color of the water was measured at 150, appearing dark brown, while the pH value was 10, indicating highly alkaline conditions. This water is not suitable for drinking or</p>

domestic use; however, it can be used directly for purposes that do not require strict water quality standards.

Sentinel-2 imagery from April 21, 2025, was used to calculate the Normalized Difference Turbidity Index (NDTI) for the Tuul River using Bands 3, 4, and 11. The results were compared with field data collected on April 20, 2025, confirming that remote sensing effectively estimates key physical water quality parameters. The first field sample, taken near the Central Wastewater Treatment Plant (47°52'11.61"N, 106°41'35.08"E), was collected to assess water color, sediment content, and turbidity in an area directly affected by the plant's discharge.

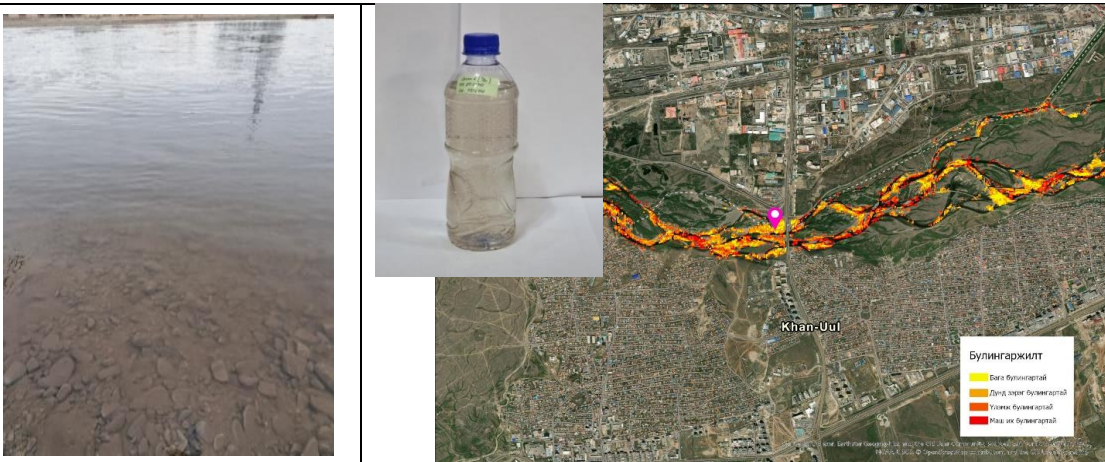
Table 3: Sampling Point 2

The second field sample was collected near Sonsgolon Bridge at coordinates 47°52'25.66" N, 106°46'57.72" E. This site is located considerably farther from the Central Wastewater Treatment Plant and was expected to have relatively better water quality conditions. However, sample collection could reflect varying conditions due to natural factors, river flow dynamics, and human activities.

Parameter, Unit	Color	pH
	Permissible Limit (MNS 4586:2024)	20	6.5 – 8.5
	Measured Value in Tuul River	45	7
<p>Note: The physical water quality parameters, including color, turbidity, and hydrogen ion concentration (pH), were assessed based on the permissible limits set in MNS 4586:2024. The water sample collected near Sonsgolon Bridge exceeded the standard limit for color, measured at 45, indicating moderate brown coloration. The pH value was 7, indicating neutral conditions. This water is suitable for all uses except drinking. If all parameters comply with the drinking water standards (MNS 0900:2018), it can be safely used as potable water.</p>

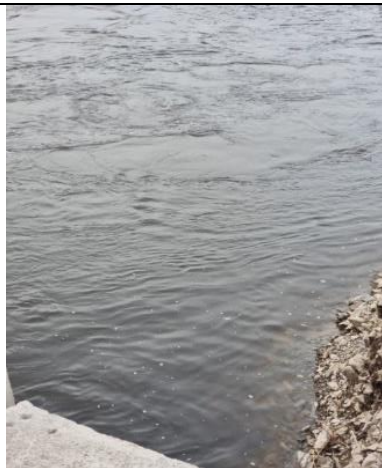
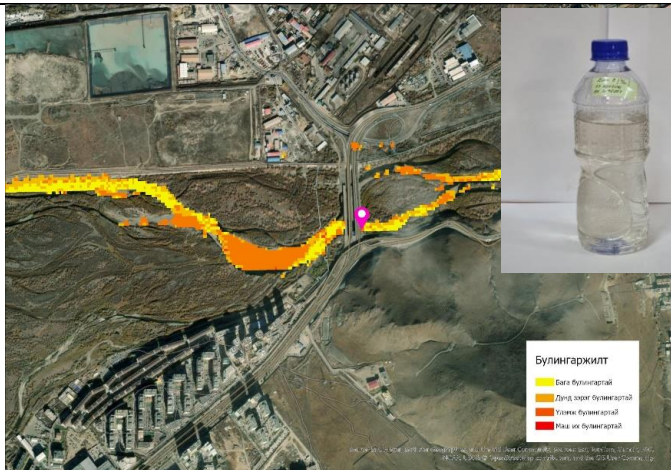
Table 4: Sampling Point 3

The third field sample was collected near Yarmag Bridge at coordinates 47°53'11.22" N, 106°51'51.32" E. This site is suitable for studying river flow and water quality. Compared to

other sections, the river near Yarmag Bridge exhibited distinct characteristics in terms of appearance and flow velocity. Variations in water color and clarity were observed, particularly in areas where the river flow increased, indicating potential changes in water quality associated with higher flow conditions.

Parameter, Unit	Color	pH	Permissible Limit (MNS 4586:2024)	20	6.5 – 8.5	Measured Value in Tuul River	25	8		
Parameter, Unit	Color	pH										
Permissible Limit (MNS 4586:2024)	20	6.5 – 8.5										
Measured Value in Tuul River	25	8										
<p>Note: The physical water quality parameters, including color, turbidity, and hydrogen ion concentration (pH), were assessed based on the permissible limits set in MNS 4586:2024. The water sample collected near Yarmag Bridge exceeded the standard limit for color, measured at 25, indicating a faint coloration. The pH value was 8, indicating slightly alkaline conditions. This water is suitable for all uses except drinking. If all parameters comply with the drinking water standards (MNS 0900:2018), it can be safely used as potable water.</p>
