Utilizing Drone Mapping Technology for Hazard Assessment of Steep Slope

Keywords: Drone, Disaster risk assessment, Point cloud, 3D modeling, Geospatial analysis

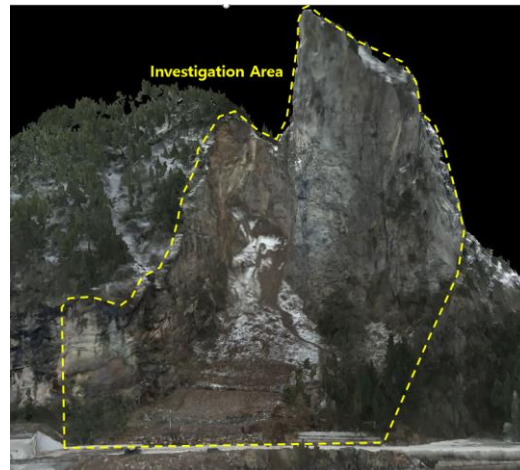
Figure 2 : 3D Terrain Model of Hyeonpo-ri District.

The orthomosaics and 3D models generated through drone mapping were used to assess hazard and disaster risk in the Hyeonpo-ri district.

For protective facilities, the 3D model showed a three-tiered rockfall protection system at the slope base. The topmost barrier was severely damaged and saturated with accumulated rocks, while the lower tiers were less damaged and could provide limited protection against small rockfalls. However, the overall protection was deemed insufficient, and repair of damaged facilities is required, indicating very poor conditions.

The district consists of tuff intruded by diorite, where prolonged weathering and erosion have caused collapse in the weaker tuff areas, forming abrupt undulating terrain. Three-tiered rockfall barriers were installed along a 110 m section of the ring road to mitigate falling rocks, but continuous rockfalls rendered them ineffective. Given the unpredictability of rockfall locations and volumes, applying reinforcement methods such as bypass roads or protective tunnels is considered appropriate.

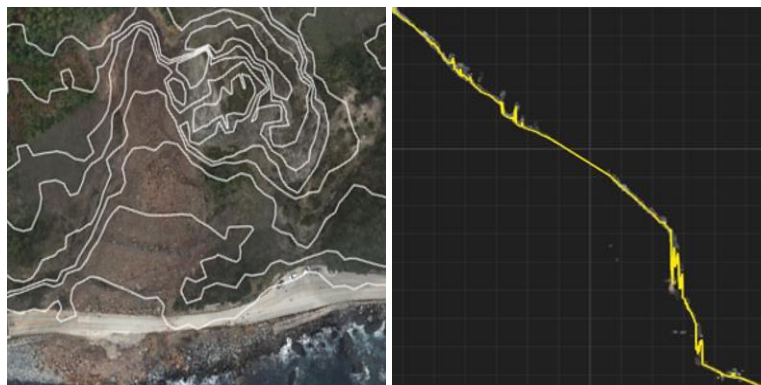
Figure 3 : Slope Shape (Left: Longitudinal, Right: Cross-sectional).

First, terrain was evaluated based on slope angle, height, longitudinal and cross-sectional forms. Using the 3D model, cross-sections were extracted at the slope collapse area (A) and the tuff slope (B) where future collapse is expected. The slope angle was measured between the slope and the horizontal plane, and the height was measured vertically from the horizontal plane to the slope summit, resulting in a height of 138 m and a slope angle of 48° . The longitudinal form refers to the slope's shape in the horizontal direction, while the cross-sectional form refers to the slope's appearance from the side. Overlaying orthomosaic with contour lines (Fig. 3) indicated that both longitudinal and cross-sectional forms exhibited complex geometries.

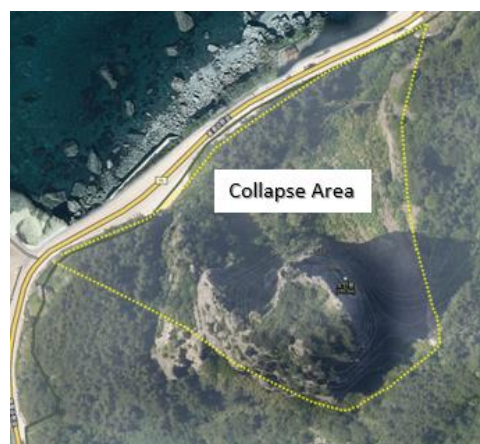
Figure 4 : Surrounding Environment.

Social impact was assessed based on the surrounding environment, roads, and nearby facilities. Orthomosaics showed that the slope base was adjacent to Ulleungdo's ring road, indicating high potential damage in the event of rockfall (Fig. 4). The nearby road is a single-lane one-way road with an average daily traffic volume of 1,343 vehicles. No other adjacent facilities were present, suggesting a low risk of direct casualties.
