DAMAGE DETECTION OF THE MAY 6, 2012 TORNADO IN TSUKUBA, JAPAN USING AERIAL THERMAL INFRARED IMAGES

KEY WORDS: Tornado, Aerial Thermal Infrared Image, Temperature Distribution, Damage Detection, GIS

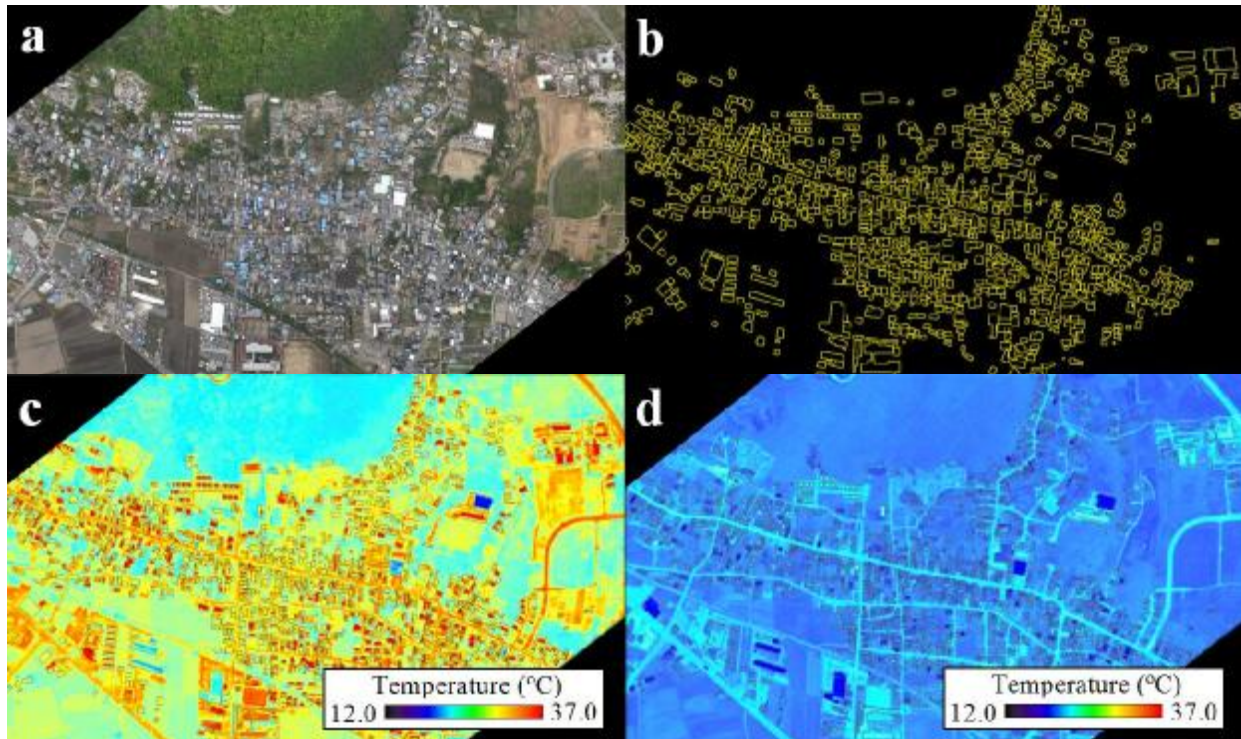
Figure 2 Visible image of Hojo district in Tsukuba City at daytime (a), building footprints created from Figure 2a (b), TIR image at daytime (c), and TIR image at nighttime on May 8, 2012 taken from helicopter.

The damage assessment was carried out in the following steps; Firstly building footprints were manually created from the daytime aerial visible image and an existing Zenrin digital map on ArcGIS software (Figure 2b). Then, damage status of each building was detected visually from the daytime aerial visible image based on the building damage classification shown in Table 1. This classification was made by Cabinet Office of Japan (2009) and it is recommended to use when evaluating the monetary loss of residential structures for local governments. In the criteria, the damage level of each wooden house is classified into 5 grades: such as no to slight (G0-G1), minor (G2), moderate (G3), major damage (G4) and collapse (G5). Out of two evaluation methods recommended, we employed the one based on the damaged floor/roof damage percentage (R) since it is suitable to apply to vertical aerial images.

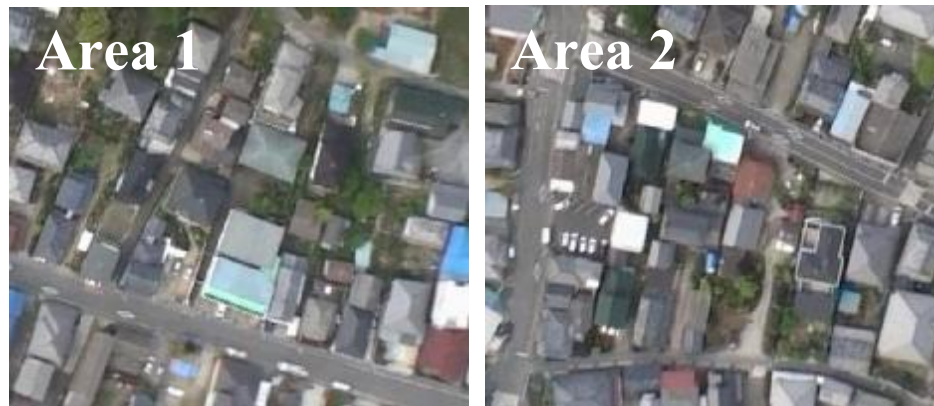
The characteristics of the TIR images at non-damaged areas were discussed first. Figure 5 show the locations of two target non-damaged areas in Figure 4. Figure 6 shows the surface temperature within the building footprints from the daytime and nighttime TIR images, superimposed on the visible image. From the daytime roof temperature distributions in Figures 6a and 6c, the roofs mostly show high temperature although some low temperature roofs exist. From the nighttime roof temperature distributions in Figure 6b and 6d, the buildings showing high temperature at daytime are still in relatively higher temperature at nighttime. It is observed that the roof temperature within a footprint of a non-damaged is mostly uniformly distributed but the effects of surrounding vegetation, shadow and footprint's accuracy can be observed around the outline.

Figure 5 Target areas of non-damage in Figure 4.

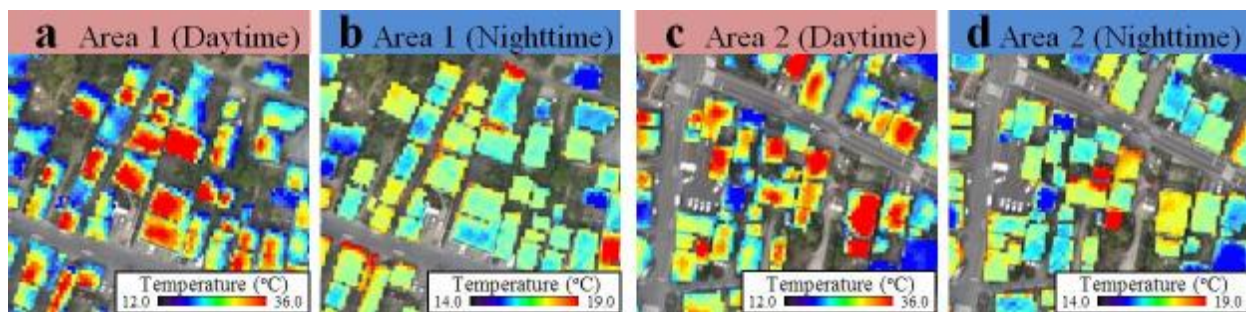
Figure 6 Temperature within building footprints for non-damage areas, a, c: Daytime, b, d: Nighttime.

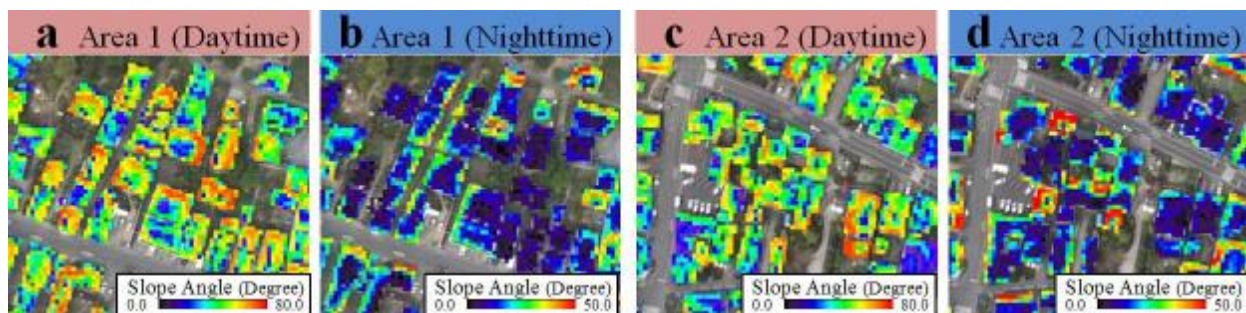
Figure 7 shows the slope angle of the surface temperature within the footprints. In calculation of the slope angle, the temperature of the adjacent pixels affected the result although the angle is shown only within the footprints. In the daytime slope angles in Figures 7a and 7c, high temperature roofs show generally larger slope angles because the temperature difference with their surroundings is large due to the difference of surface materials. In the nighttime slope angles in Figure 7b and 6d, the slope angles within some building outlines are displayed red color affected by surrounding road or vegetation. However most building roofs are in low temperature with uniform distribution, and thus their temperature change within its outline is small.

Figure 7 Slope angle of the temperature within building footprints in Figure 6, a, c: Daytime, b, d: Nighttime.
