INSPECTION OF PAVEMENT SURFACES BY THERMOGRAPHY

Andrew KUTTIN-MENSAH*¹, Mitsuharu TOKUNAGA², Ernest APRAKU¹, Latif SUBOI¹

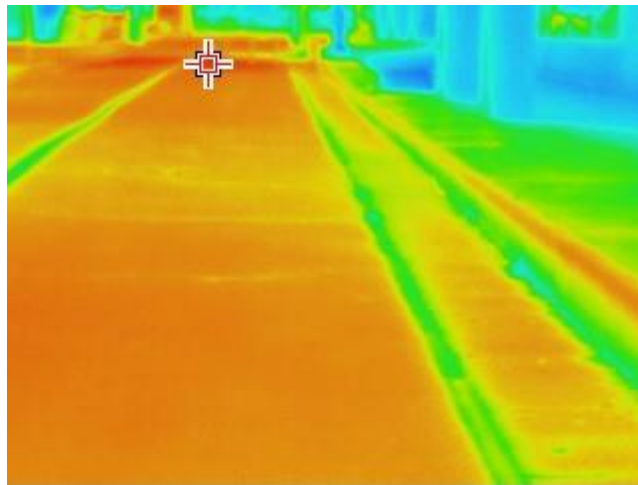
Figure 6 Thermal Imagery

pavement in this way allowed for identification of defects in relation to the carriageway (Figure 6), otherwise the image viewed cannot be comprehended. Also, the set up prevents solar radiation from reflecting of the car directly into the thermal camera.
